## GAS TURBINE FAILURE DUE TO WATER WASH AND EXTRACTION LINE BLOCKAGE

Abdulmajeed A. Ali

Saudi Aramco, Yanbu NGL Fractionation Department  
Industrial City, Yanbu, Saudi Arabia  
[abdulmajid.ali@aramco.com](mailto:abdulmajid.ali@aramco.com)

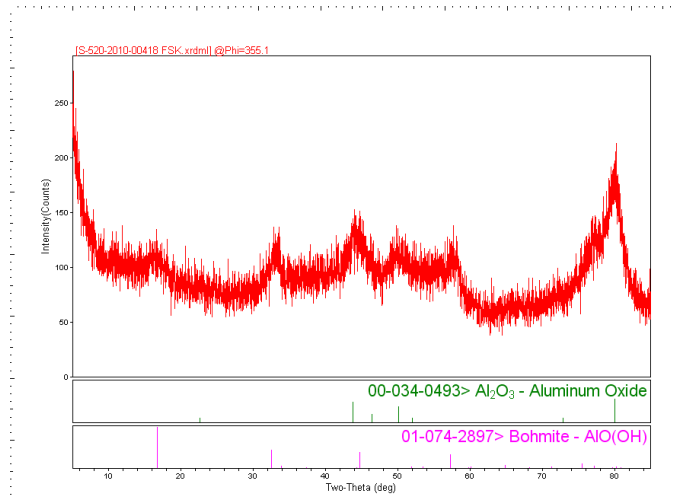
Materials Data, Inc. [BC418213ibuser] © W'P'rt Data Wednesday, July 21, 2010 02:39 (MDI/JAD/EB)  
**Figure-1 XRD Diffractogram of Sample #1 Original Desiccant**

The XRD results showed that the original desiccant mainly consists of  $\gamma$ -alumina ( $\gamma$ - $Al_2O_3$ ) (activated alumina) with minor amounts of boehmite- $Al(OH)_3$ , whereas the deposited powder material contains boehmite- $Al(OH)_3$ , bayerite- $Al(OH)_3$ , and gibbsite- $Al(OH)_3$ . WDXRF results confirmed XRD findings. Based on analytical results, it was concluded that the original desiccant is the source of deposited material, as activated alumina desiccant can absorb the moisture (water) and be transformed into bayerite- $Al(OH)_3$ , and gibbsite- $Al(OH)_3$  during the operation process ( $Al_2O_3 + H_2O \rightarrow Al(OH)_3$  and  $Al(OH)_3 + H_2O \rightarrow Al(OH)_3$ )

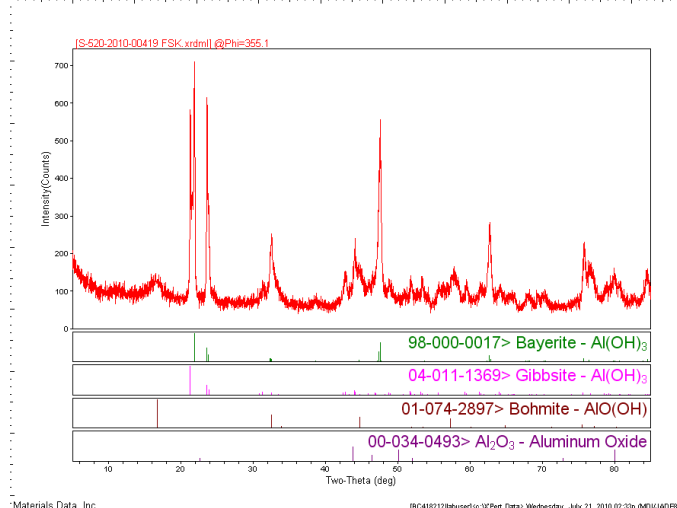
Materials Data, Inc. [BC418213ibuser] © W'P'rt Data Wednesday, July 21, 2010 02:39 (MDI/JAD/EB)  
**Figure-2 XRD Diffractogram of Sample #2 Deposited Powder**

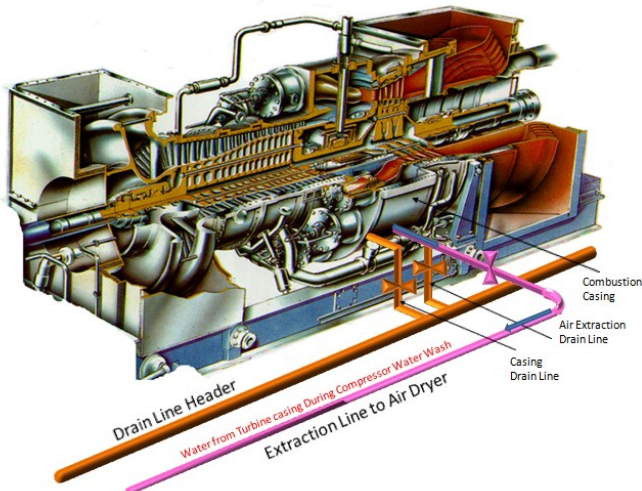
Improper MOV configuration lead to a large volume water supply to the compressor and combustion chamber while the turbine unit was in the operating mode, and the isolation valve of the air extraction pipe was lined up in the open position, while all drain lines were lined up in a closed position (correct line up in the operating mode). This made water strike the cross firing tubes that were extremely hot, causing quenching of the material and sudden shock cooling, resulting in material fracture. The fracture material flowed with the exhaust stream, hitting turbine buckets/nozzles and magnifying damage that lead to more fracture material from the turbine buckets and nozzles.

Figure-4 Drain and Air Extraction Line Configurations

- Emphasizes the quality of commissioning and start-up check lists to ensure smooth and safe operation process.
- Install permanent non-return valve at the air extraction line.
- Conduct appropriate periodic preventive maintenance of the Heater-less Air Dryer System.

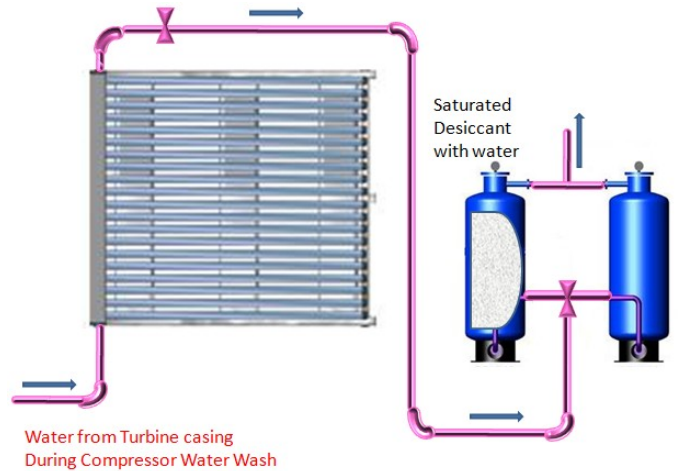
A massive amount of water flowed from the air extraction pipe to the heater-less dryer skid system, with the aid of the pressurized air from the compressor (120 psig and 670 °F). This influx resulted in dissolving the desiccant in the dryer tower tank vessel and blocking the dryer downstream skid valves. This blockage trapped air in the dryer system under positive pressure (see figure 5).

Figure-5 Heater-less Dryer Skid System

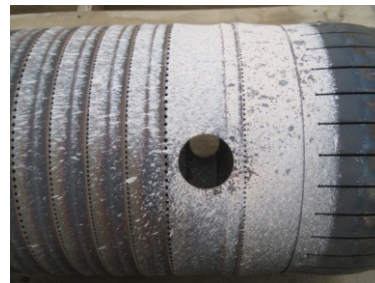
Figure No.6 White scale covering the combustion liner air passes.

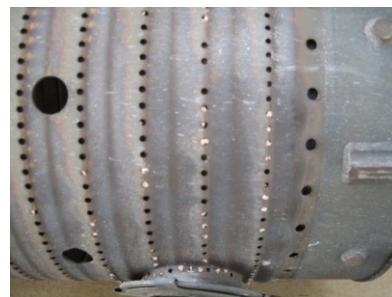
Figure No.7 Air passes blocked by white scale on combustion liner.

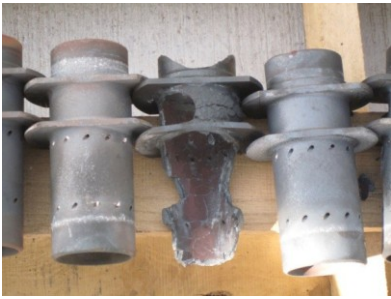
Figure No.8  
Melted and broken material of cross firing tube bodies.

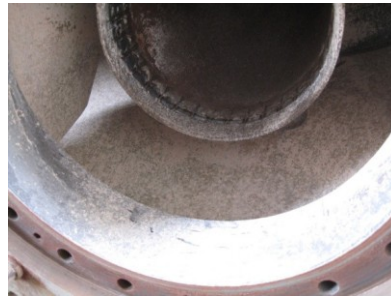
Figure No.12  
White scale patterns sprayed on the transition piece.

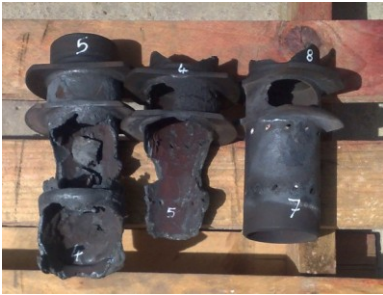
Figure No.9  
Broken and melted material from cross firing tube bodies.

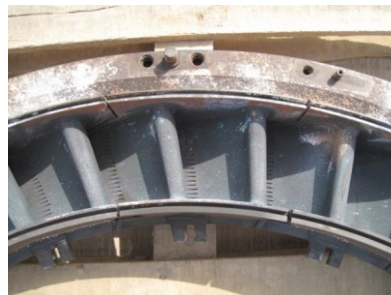
Figure No.13  
White scale element and burnout on first stage turbine nozzles bottom half.

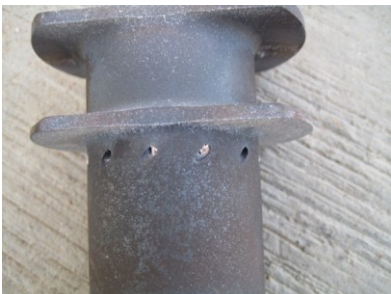
Figure No.10  
Cross firing tube air cooling passes blocked with white scale.

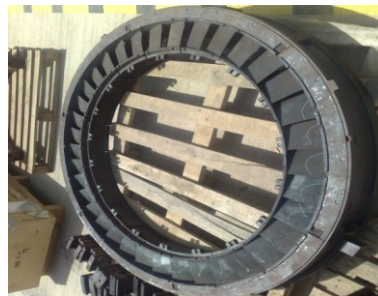
Figure No.14  
Signs of burnout on first stage turbine nozzles.

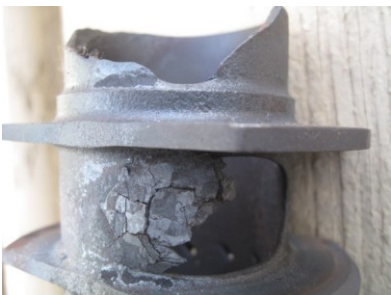
Figure No.11  
Cross firing tube metals broken by quenching.

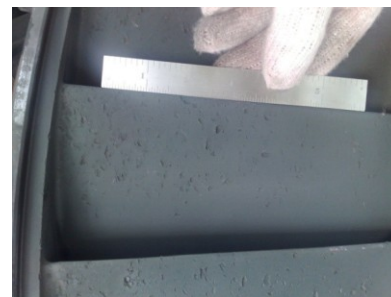
Figure No.15  
Second stage turbine nozzles scaling the dents.

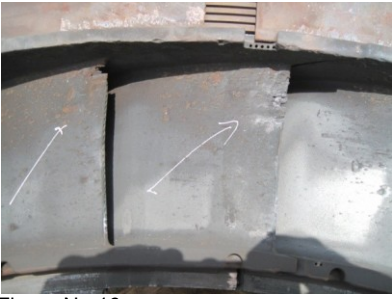
Figure No.16  
First stage turbine nozzles bottom half, with signs of broken metal.

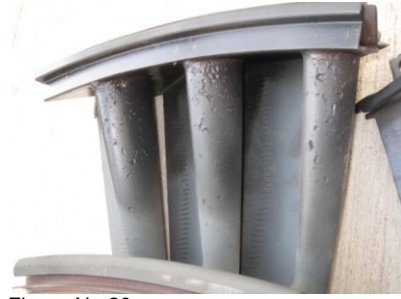
Figure No.20  
Signs of dents on second stage turbine nozzles.

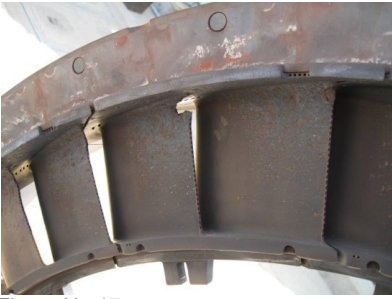
Figure No.17  
Signs of broken metal and dents on first stage turbine nozzles upper half.

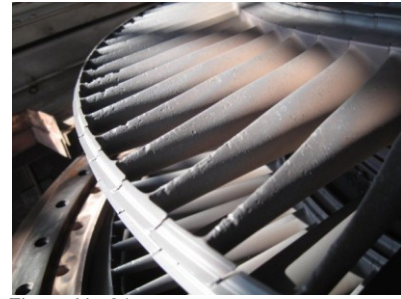
Figure No.21  
Signs of dents and broken metals on second stage turbine bucket.

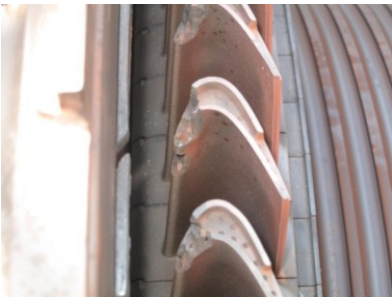
Figure No.18  
Broken edges on first stage turbine bucket.

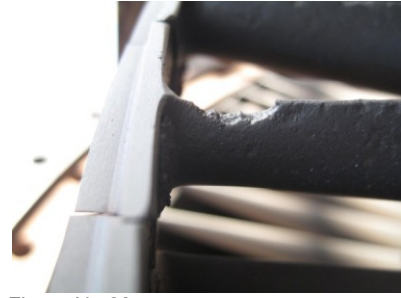
Figure No.22  
Signs of dents and broken metals on second stage turbine bucket.

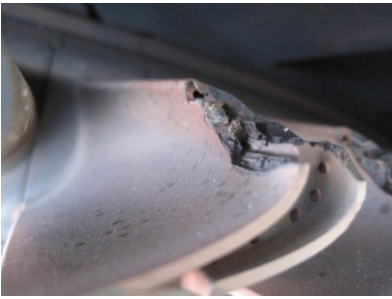
Figure No.19  
Broken edges on first stage turbine bucket.

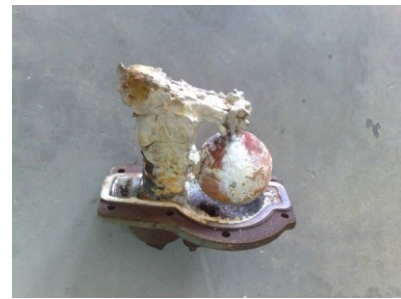
Figure No.23  
Water trap valve cover and plunger covered with white solidified element (desiccant).

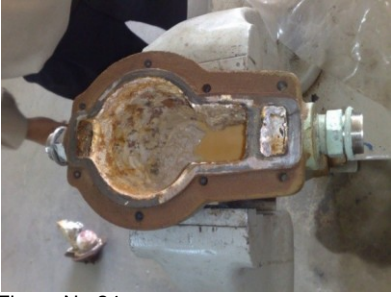
Figure No.24  
Water trap valve body is covered with white solidified element (desiccant)
