GT2011-46+* *

REPAIR PROCESS TECHNOLOGY DEVELOPMENT & EXPERIENCE OF FRAME 7FA+E, STAGE 1 TURBINE BUCKETS

**Warren Miglietti, Juan Escudero, Julio Lanza and Ian Summerside
Power System Mfg, LLC (PSM) - An Alstom Company, Jupiter, FL, USA
Zaki Zainuddin
Alstom, Baden, Switzerland**

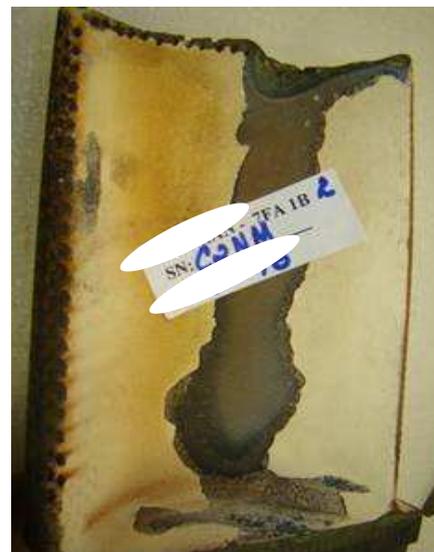
Figure 2 - Overall view of the worst engine run Frame 7FA, stage 1 bucket in a particular engine set

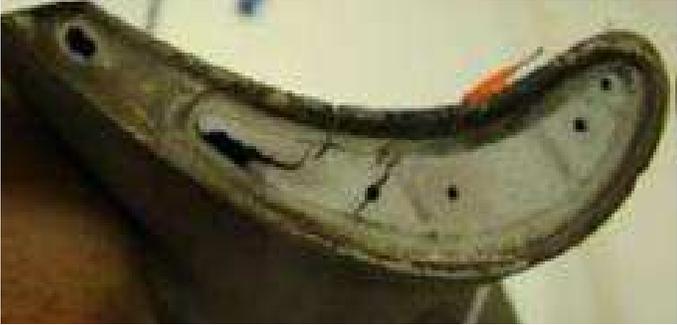
Figures 3 and 4 show bucket tip cracking & fig’s 5 and 6 show pressure side TE and LE platform cracking respectively.

Figure 3 - Airfoil tip oxidation and cracking

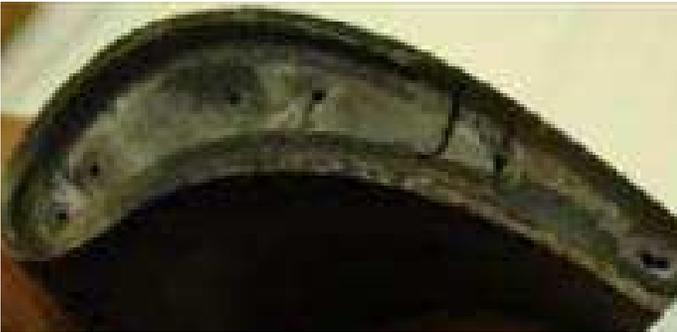
Figure 4 - Airfoil tip oxidation and cracking

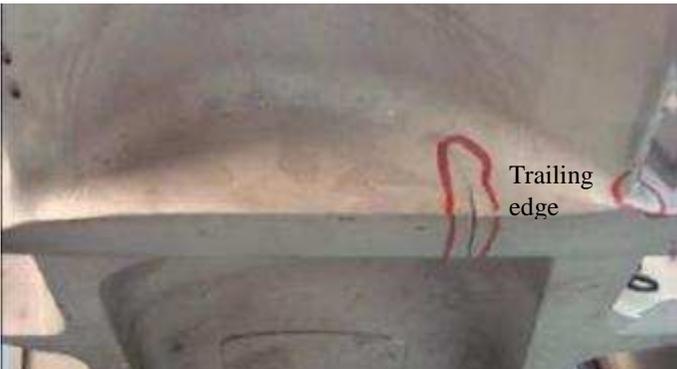
Figure 5 – Pressure side TE platform cracking

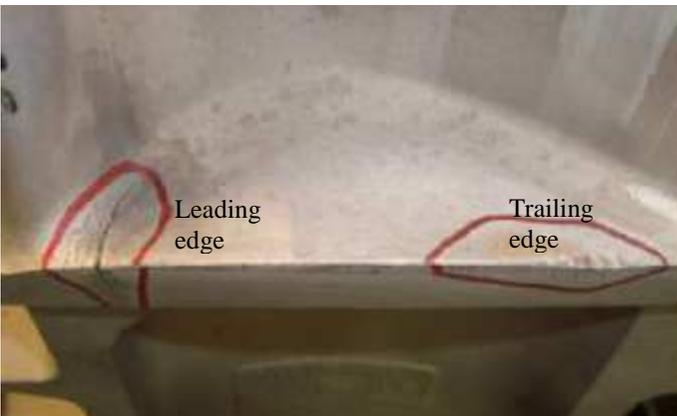
Figure 6 – Pressure side LE and TE platform cracking found during penetrant inspection

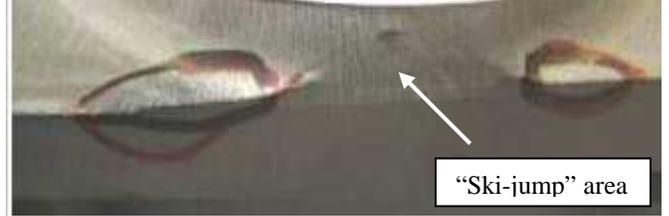
Figure 7 shows suction side platform cracking. The pressure side LE fillet and TE fillet platform crack has a

Figure 7 – Suction side platform cracking

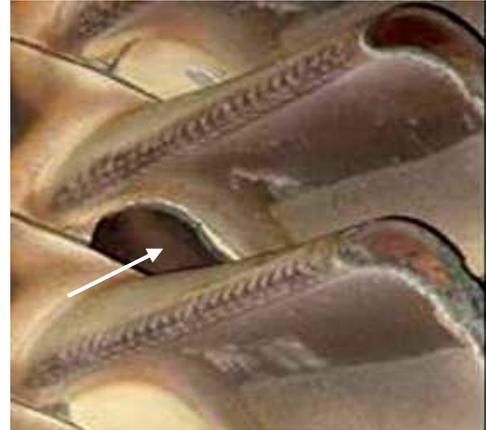
tendency to meet each other, i.e. propagate along the fillet radius region and liberate the entire platform as seen fig 8.

Figure 8 – Liberation of pressure side platform

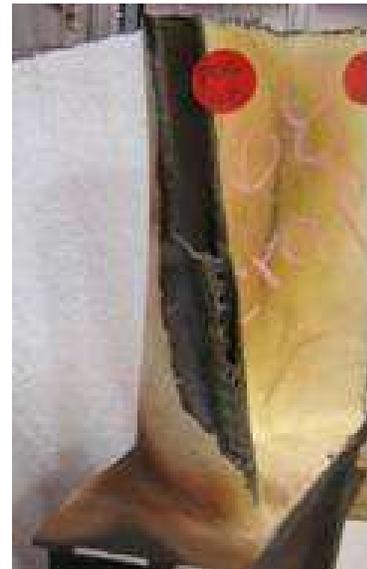
In some isolated occasions, as seen in fig 9 part of the tip cover plate liberates and the entire LE burns away.

Figure 9 – Leading Edge Burn Through

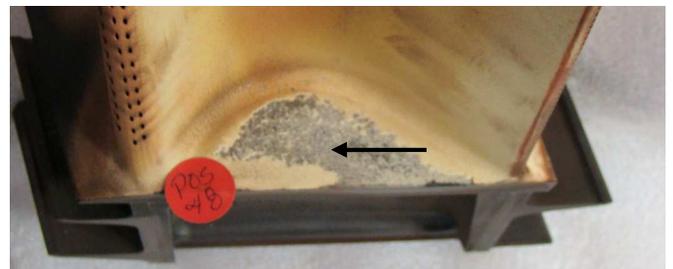
Figures 10 and 11 show platform oxidation, and tip oxidation + cracking respectively. It is really the platform degradation that lowers the repair yield and is the main challenge for reconditioning this bucket. Figure 12 shows TE cracks. It is very important to understand why the component degraded in order to effectively recondition it.

Figure 10 – Platform oxidation

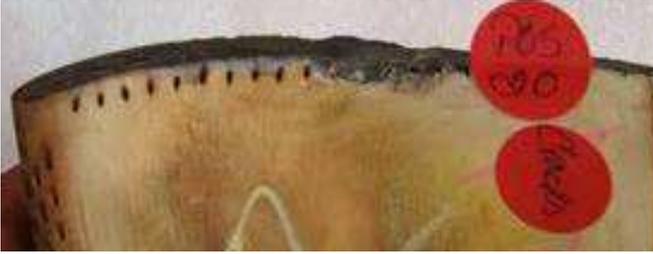
Figure 11 – Tip oxidation and TMF cracking

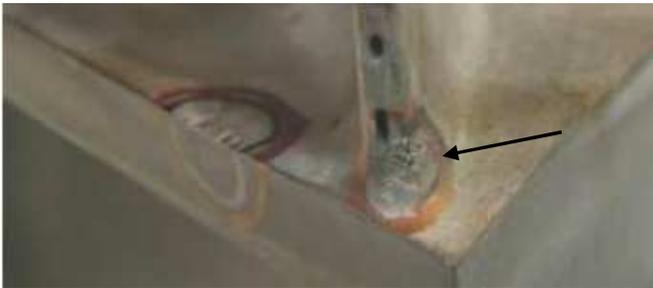
Figure 12 – TE cracking

Figure 39 shows the platform cooling configuration applied to buckets that arrive for repair without any platform cooling. Figure 40 shows the VCHD TBC also applied to the tip cavity. Figure 41 shows the alternative TE undercut to that supplied by the OEM, which is applied to buckets that arrive for repair that do not have any TE undercut. Figure 42 shows the modification to the shank to allow for cooling air to reach the platform and fig 43 which is not really an upgrade, is the trailing edge cut-back (scallop) applied to buckets that arrive for repair with TE cracks as seen in fig 12.

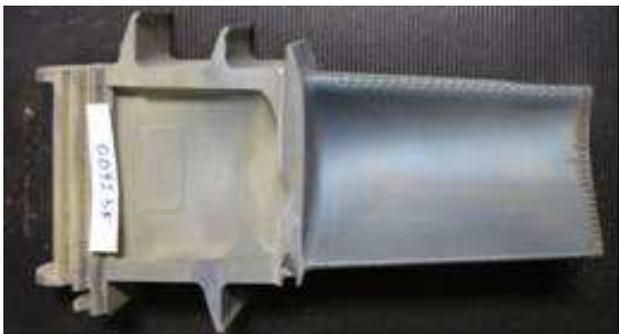
Figure 13 – Pressure side view of the bucket indicating a bluish heat tint condition

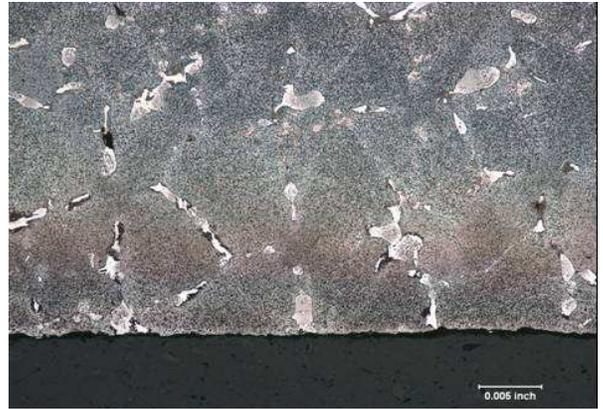
Figure 14 – Metallurgical evaluation of the base metal after acid stripping showing acceptable IGA

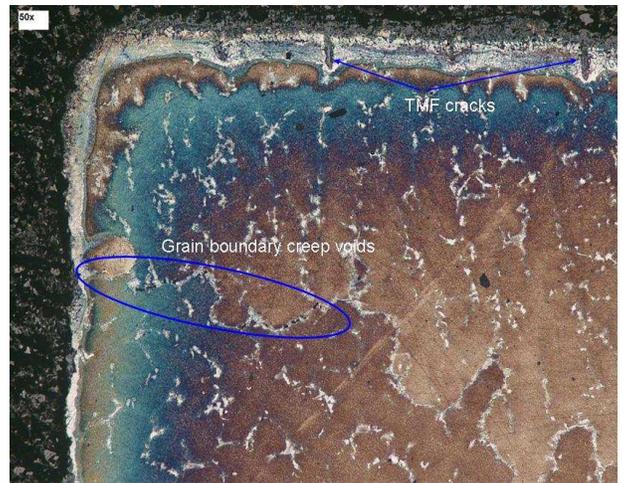
Degradation of the platform area in service initiates via the well-known mechanism of thermal-mechanical fatigue (TMF) and then propagates in TMF/Creep (hold time) mode. TMF damage results from the high thermal transient stresses from the unit start-stop cycles, and manifests itself at the bucket platform as numerous heavily oxidized radial cracks along the platform edge (see fig 15). The prevalent location of cracking can be seen in figures 5 and 6. Note, the crack as viewed from the slash face side of the platform does not surprisingly initiate at the grain boundary and actually occurs intragranularly. An example of a platform crack can be seen in fig 16. Since the platform consists of 1 – 4 large grains and its orientation is different from that of the airfoil grains, i.e. it is orthotropic (has the different materials properties or strengths in different orthogonal directions). The stiffness of the platform is dependent on orientation of these grains and it is this stiffness that dictates the strain distribution and where the TMF crack initiates.

Figure 15 – Evidence of TMF cracks and creep voids/cracks in the platform area of the bucket.

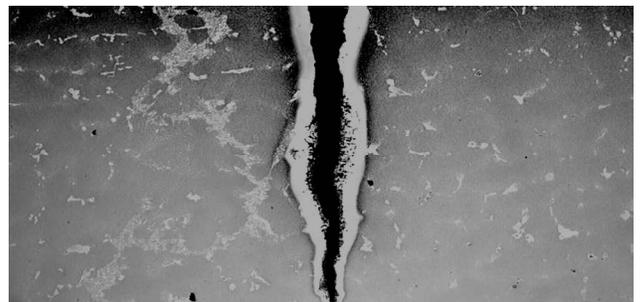
Figure 16 – Oxidized crack found on the platform

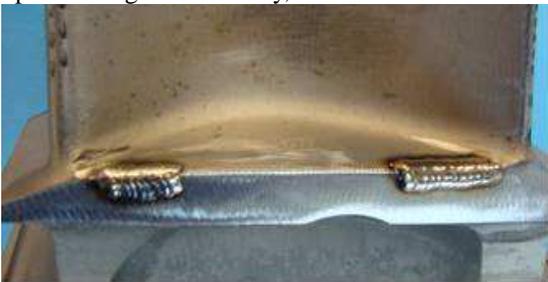
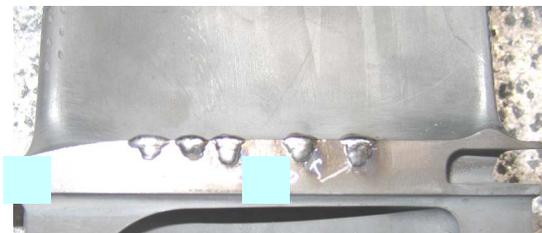
Figure 17: Platform crack repair via high frequency GTAW using new novel weld filler metal

Figure 18: Platform crack repair via high frequency GTAW using the new novel weld filler metal

Excellent manual high frequency GTA welds were produced at room temperature, as seen in fig's 17 and 18, using the specially developed weld wire in the platform areas, with no post-weld heat-treatment cracking observed. Metallographic evaluation also confirmed that the weld repair was of good quality, since no HAZ microfissuring or fusion zone cracks were evident as seen in fig's 19 and 20. In fact fig 20 shows a weld produced with this high frequency welding process using the novel weld filler metal that occurs over a grain boundary, and one would expect a crack to have developed at the grain boundary, but none was evident.

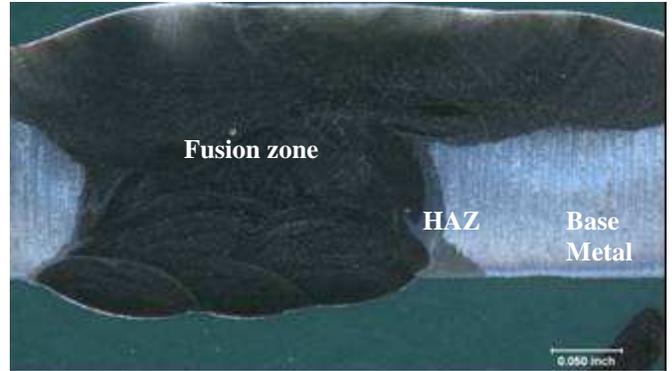
Figure 19 – Cross-section of weld repair showing no microfissuring or post weld heat treatment cracking

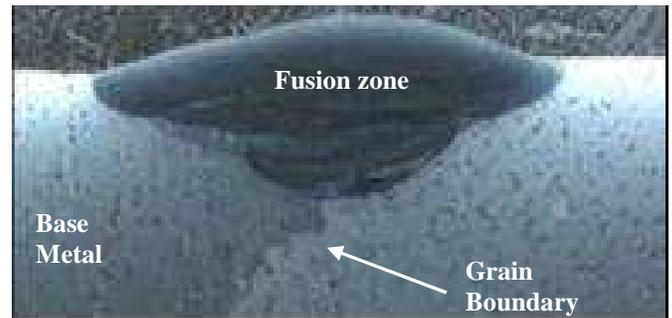
Figure 20: Platform crack repair via high frequency GTAW using new novel weld filler metal

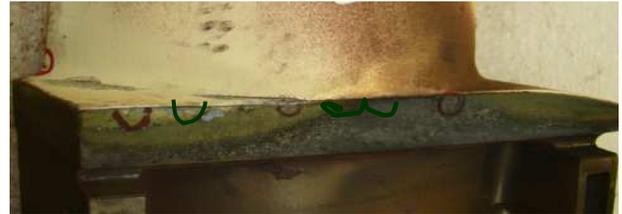
During development of the weld repair on scrap buckets it was found in some cases that there were numerous cracks on the suction side of the platform as seen in fig 23. When the weld repair was taking place, the cracks propagated into the airfoil region as a result of the thermal heating and contraction rates, during the weld repair process. As a result it was decided to grind off a specific amount, thereby removing all of the cracks and doing a braze build up using a braze preform of proprietary composition as shown in fig 24. Since the bucket had to undergo a post weld heat treatment anyway, the braze cycle was implemented to coincide with the post weld heat treatment temperature, thus avoiding 2 thermal heat treatments, i.e. a post weld heat treatment and a braze run. With diffusion brazing, since the bucket is heated up and cooled uniformly in a vacuum furnace (unlike welding where the heat is localized) cracks did not propagate into the fillet or airfoil regions during heat up and cool down. Figure 24 shows the application of the braze preform to the slash face on the suction side of the platform.

Figure 23 – Suction side platform cracks. 6 cracks marked at FPI are evident on the slash face.

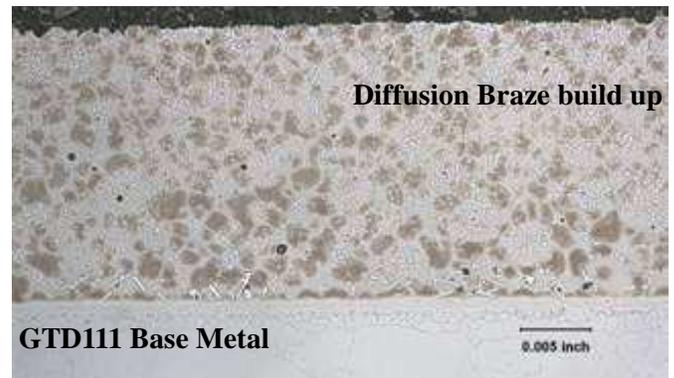
As can be seen in figure 25, the braze preform has bonded well with the DS-GTD111 material. The microporosity in the diffusion brazed region is less than 1%. The tensile strength as

Figure 25 – Micrograph of the diffusion braze build up using a braze preform.

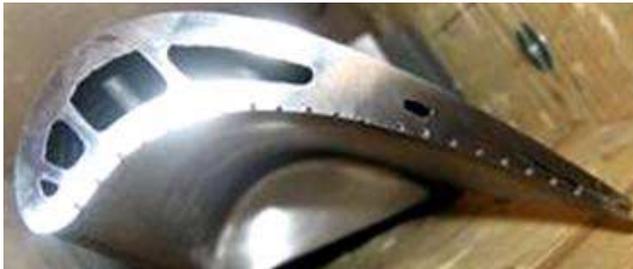
Figure 26 shows the squealer tip and EB welded cover plate that was removed via grinding and one can also see the core cavities exposed as well as that there are numerous cracks on the bucket tip region.

Figure 26 – Squealer tip and EB welded cover plate that were ground off to expose the core cavity

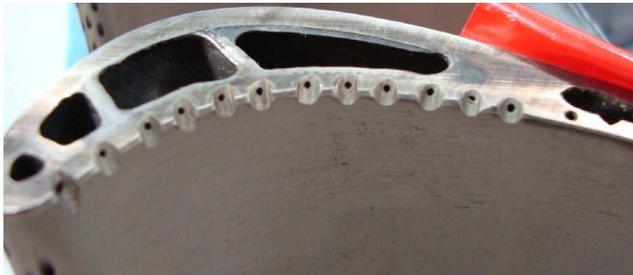
Figure 27 – Bucket prepped for tip crack weld repair

Figure 27 shows the bucket prepped for tip crack weld repair and fig 28 shows the tip cracks weld repaired using the high frequency GTAW process.

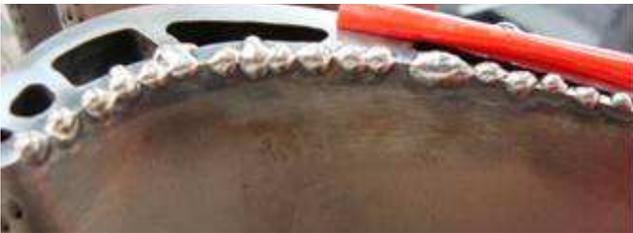
Figure 28 – Weld repair of cracks at the tip of the bucket

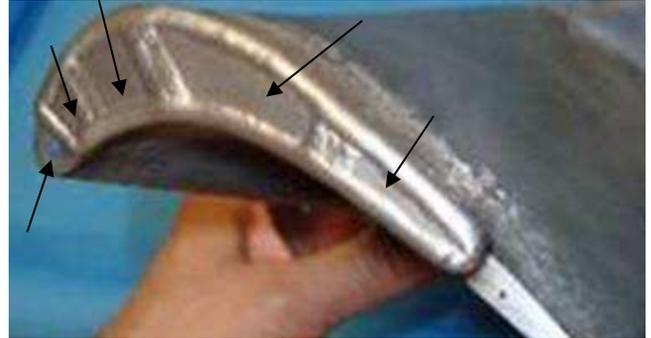
Figure 29 – Five new chicklets GTA welded on the tip of the bucket to close the core cavities

Figure 29 shows the 5 new chicklets welded on to close the core cavities. The squealer tip originally was manual GTA weld restored but after implementing this process on the first 2 production engine sets it was found that it was extremely labor intensive and as a result the laser cladding repair was developed.

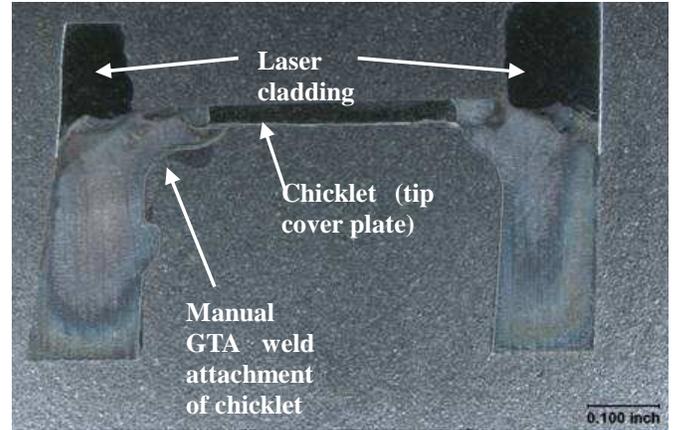
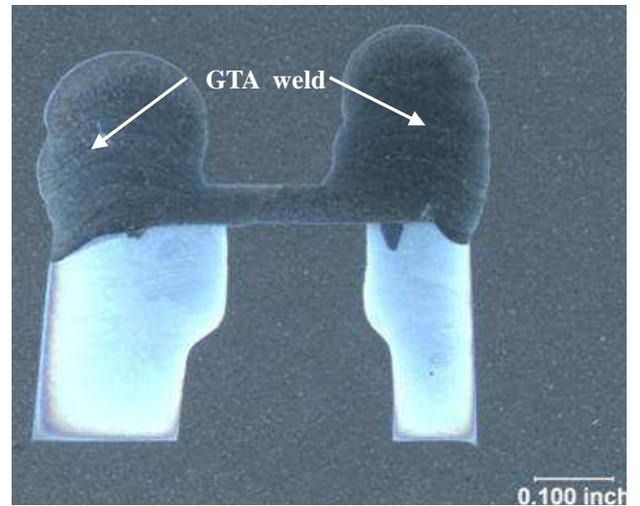
Figures 33 and 34 show the metallurgical results of the entire chicklet weld attachment and the squealer tip restoration. As can be seen, weld cracking is not evident because a smaller laser weld pool volume usually translates into lower solidification stresses and there is good fusion and bonding to the bucket tip and chicklet material.

Figure 33 – Manual GTA weld attachment of the chicklet and laser cladding of the squealer tip

Figure 34 – Manual GTA weld attachment of the chicklet and manual GTA weld of the squealer tip

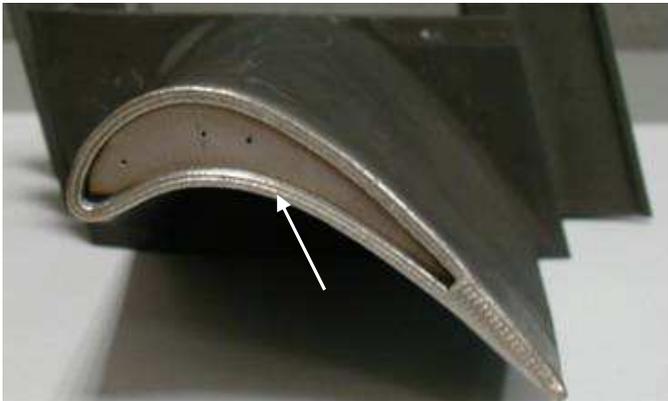
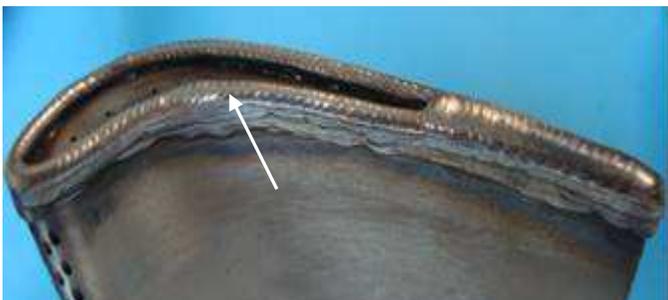
Figure 30 shows the set up of the laser welder during cladding of the squealer tip. Figures 31 and 32 show the difference between the laser clad restoration of the squealer tip versus the manual GTA weld build up. As can be seen the laser cladding restoration is near net shape, resulting in a reduction in not only cycle time but also blending time, (i.e. the squealer tip has to be contoured to that of the bucket shape). In addition the difficulties associated with weld cracking of the GTD111 superalloy while simultaneously trying to find a way of making the repair more productive than by manual GTA welding, resulted in laser cladding technology now being implemented on all production bucket repairs at this facility. The entire bucket tip weld repair, inclusive of chicklet weld attachment and the squealer tip restoration was evaluated metallurgically. The chicklet material was specially chosen and is more oxidation resistant than the GTD111 base metal. Similarly the weld filler for attaching the chicklets to the bucket as well as restoring the squealer wall was specially developed and is more oxidation resistant than the GTD111 base metal.

Figure 31 – Laser cladding of the entire squealer tip

Figure 32 – Manual GTA weld restoration of the bucket squealer tip

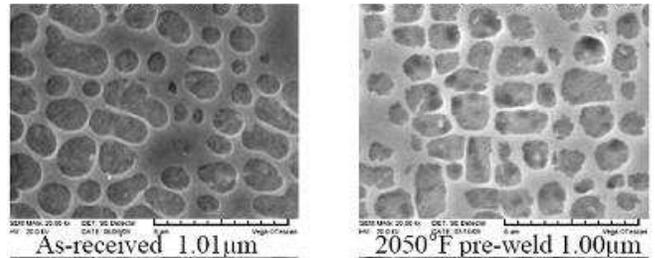
During the metallurgical assessment of engine run buckets, it was observed that the gamma prime (γ') phase coarsened, and the formation of a γ' layer along the grain boundaries, was discovered. This condition reduces the creep strength and the ductility of the bucket material because these grain boundary films are brittle and can act as nucleation sites for creep voids (ref 7); although no evidence of creep voiding was detected in the airfoil areas.

Figure 37 – Morphology of the engine run material showing significant coarsening of the γ' phases (LEFT) and little change in γ' morphology after the standard 1121°C (2050°F) heat treatment (RIGHT)

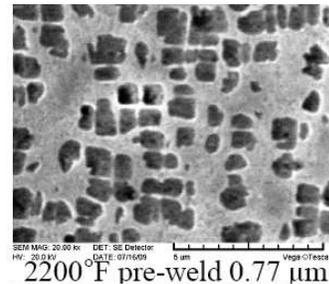
Figure 38 shows the dramatic and significant change in γ' morphology, with an ideal cuboidal shape and size forming as a result of the super-solvus rejuvenation heat treatment. Stress rupture tests were conducted to assure that the changes to the integrated heat treatment schedule did not degrade the creep rupture properties. Table 2 shows that the rejuvenation heat treatment improved the stress rupture properties by a factor of 3 to 16X depending on the test temp. Although the simple short tests performed in Table 2 indicate that the specification minimum has been met, long term creep rupture tests in the order of 1000 hours have been achieved, to ensure that the rejuvenation heat treatment is successful.

Figure 38 – Morphology of the rejuvenated material showing an ideal distribution of cuboidal γ' phases
