COUPLING FAILURE FOR TORSIONAL FATIGUE: A MULTI-DISCIPLINARY ROOT CAUSE ANALYSIS APPROACH

GE Oil&Gas, Florence, Italy, I-50127,
valerio.rossi@ge.com

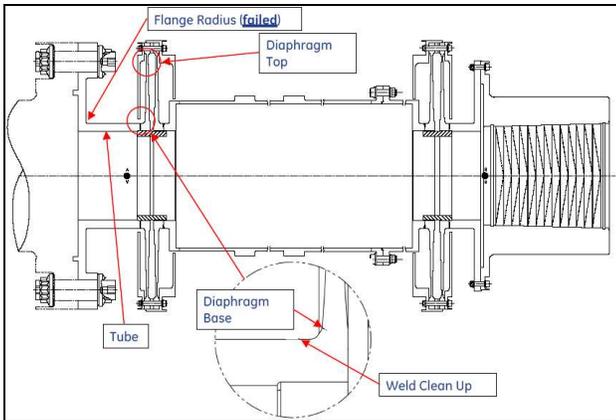
Figure 3: COUPLING DRAWING

Initially each issue was addressed with a different RCA until a major failure occurred on November 2008. At that time high-high radial vibrations were detected on GT radial probes; a visual inspection of the GT-CC load coupling highlighted a clearly visible crack on the flange radius.

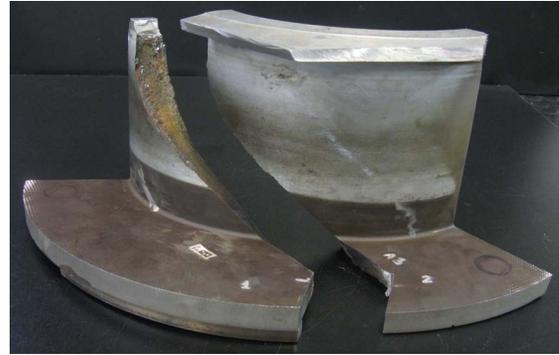
Figure 4: DAMAGED COUPLING

The root cause analysis has been performed on the gas turbine flexible load coupling in the CC train driven by dual option GT-motor drivers. The coupling design was fabricated from a low alloy steel with 1% of nickel. An image of the broken coupling flange adaptor is showed in .

Looking to the component and the fracture surface, there are clear evidences of a fatigue fracture during service.

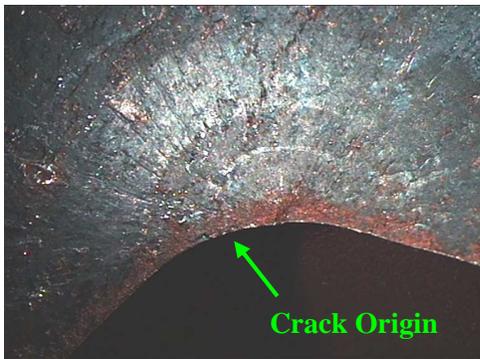
Figure 6: STEREOSCOPIC IMAGE OF THE CRACK ORIGIN ZONE

As can be seen, the fracture surface shows characteristic fatigue path propagation. It is simple to identify the crack initiation zone and the propagation due to fatigue stress. At higher magnification is also possible to identify secondary cracks just below crack origin area. The fracture surface shows different zones, characterized by two different colors, which probably indicates different service condition from the initiation of the crack through the propagation of the flaw to critical size and fracture. Since more detailed investigation of the two zones was required, a higher magnification was called for.

It is very important to note that no defects related to corrosion damage on the surface, subsurface material quality (metallurgical issue) or machining (scratches) on the crack initiation surface were detected and the initial hypothesis was that the defect could have been initiated during fatigue cycles higher than the limits.

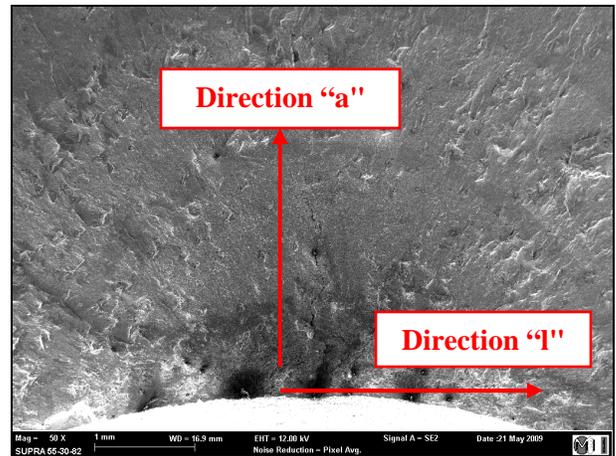
Figure 7: SEM IMAGE OF THE CRACK ORIGIN ZONE

At this magnification, is very simple to identify the different zones and is important to make a photographic documentation.

The principal scope of the SEM analysis is to measure and count the fatigue striations. Following the principal growth direction of the cracks (identified with “a” and “I” starting from crack origin, see ; crack dimensions are ~18 mm in “a” direction and ~35 mm in “I” direction), the fatigue striations per micron have been counted, at different distances from initial crack zone. An example of analyzed zone is shown in **Error! Reference source not found..**

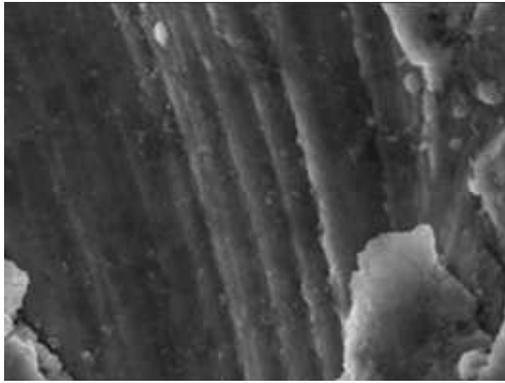
Figure 8: STRIATIONS IN “A” DIRECTION

This is a fundamental phase, because the striations per micron are one of the elements of data necessary for estimating the actual alternating stress cycles acting on the components and for determining the cyclic growth controlling the damage to the coupling.

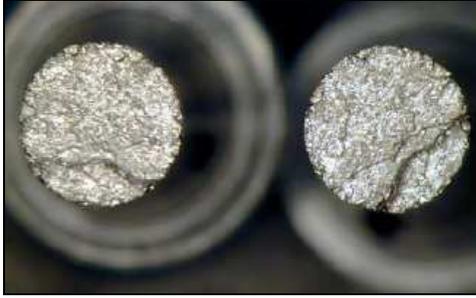
Figure 14: BRITTLE SURFACE OF TENSILE SAMPLE

This tensile tests are generally consistent with the material specification requirements except for the low ductility values that should be connected with different fiber orientation in different zones of the component (that lead the elongation to have very low values). The figure shows the brittle appearance of the final failure, consistent in brittle behaviors of the material, in particular in the flange radius area. In are resumed the required and the obtained tensile characteristics.

The most significant root cause proven in this investigation is suboptimal forging fiber orientation, which makes the finished piece less deformable than expected and below specifications, especially close to the failed flange radius. The yield stress and the tensile strength are inside the specific requirements wherever the specimen is taken. On the other hand the fatigue test revealed that the infinite life fatigue limit of the material is 334 MPa instead the nominal value 490 MPa (32% below expectations).

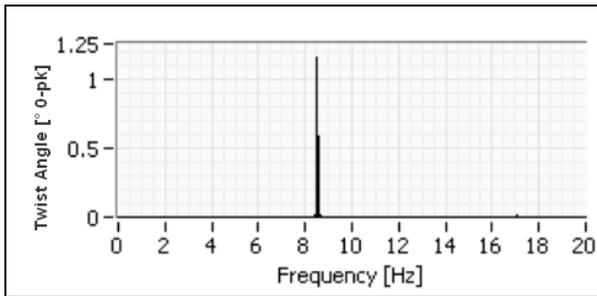
Figure 16: FFT OF TV AT 14 MW HM LOAD

In order to investigate the influence of the HM on this phenomenon, it was tested raising the load from 1 to 14 MW. It was noted that until the load remained below 11 MW the level of TV was almost steady with values within acceptable limit. The situation changed when overcoming 12 MW becoming finally dangerous at 14 MW where TV reached 1.1° of angular oscillation.

gives a screenshot of TV FFT analysis at 14 MW HM load: the 1st TNF component is clearly visible.

The hypothesis of high TV as a root cause was then reinforced by the test measurements at site, as alternating torque values up to 112 kNm 0-pk were detected.

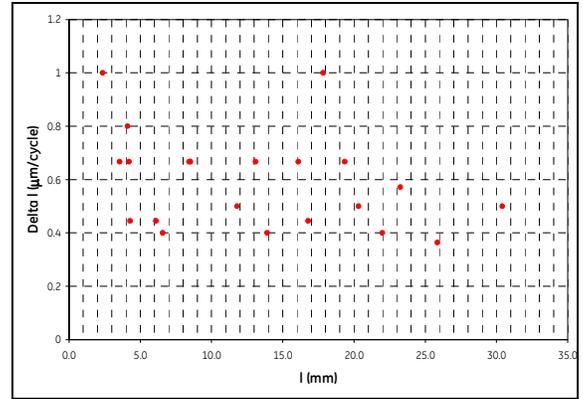
Figure 21: STRIATION DENSITY IN "L" PROPAGATION DIRECTION

For different regions of the fracture surface (like shown in), there are calculated stresses and torques necessary to have propagation in accordance with the counted fatigue striations. These calculations are performed using an internal tool, based on British R6 formulas that take in account the different geometric parameters used to calculate the ΔK during propagation of the crack (stress are constant during propagation, in accordance with the code). This value determines the real alternating load acting on the component.

As can be seen, this distribution of striation/micron is very different in respect with expected trend. In this case, there is a higher variability of distribution, different depending on the analyzed area. This is a clear index of the different stresses acting on the component during crack propagation.

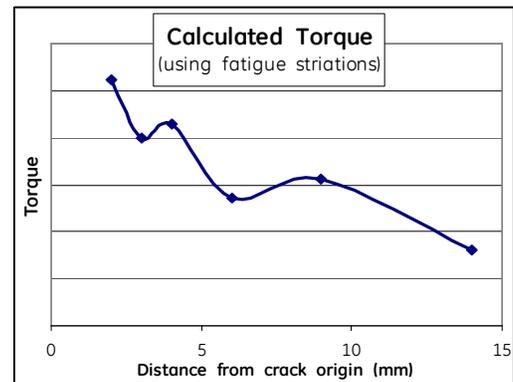
Figure 22: TORQUE VS CRACK PROPAGATION

Plotting the torque values that can promote crack propagation in the various analyzed points (the red points in), is simple to verify that this parameter has an "oscillating" trend but it decreases with the distance from the crack origin (lower stress need to crack propagation with bigger defect). It is very important to pay attention that the "rough" zones are characterized by higher value of the stresses during propagation (in the graph, the peak are relative to the rough zones). In the trend of torque vs crack propagation is shown.

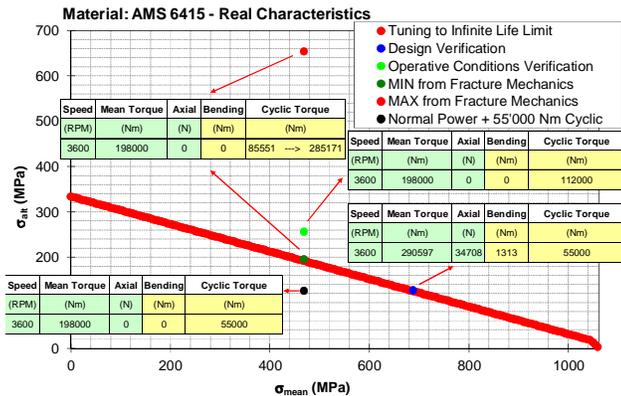
Figure 23: SUMMARY GOODMAN DIAGRAM

Finally, using the cyclic torques calculated by the fracture mechanics and confirmed by the torsional measurements, and considering the real material fatigue characteristics, we obtained a multitude of potential operative points on the Goodman diagram above the infinite life range, demonstrating the potential weakness of the failed part longevity on the mentioned operative conditions.

The measurement campaign carried out showed for short operational periods where cyclic torque is very high (112000 Nm). This torque, combined with a normal steady torque of 198000 Nm (74650 KW) is sufficient to drive the coupling to a fatigue failure in the flange radius location – combined with the fact the infinite life fatigue limit of the material is 334 MPa instead the nominal value 490 MPa (32% less).
