Failure Investigation of a 6th Stage Compressor Blade on a ETF40B Gas Turbine Engine

Gerrick Slogar (<u>Gerrick.Slogar@Vericor.com</u>) Vericor Power Systems Inc. 3625 Brookside Parkway Suite 500 Alpharetta, GA 30022 Gary Prus (gpp@psnet.com) Parametric Solutions Inc. 900 East Indiantown Rd. Suite 200 Jupiter, FL 33477 Benjamin Canilang (benjamin.calilang@Navy.Mil) Naval Surface Warfare Center, Carderock Division Philadelphia, PA Branch 935

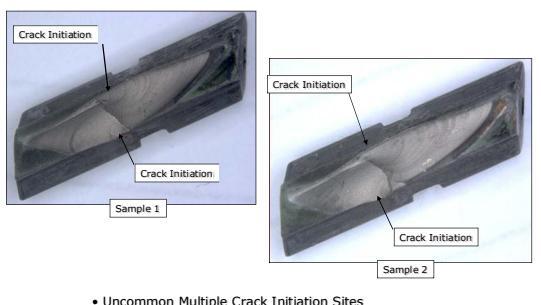
Figure 2 ETF40B 6th Stage Blade Fracture Surfaces

The fracture surfaces of the two missing 6th stage blades were visually and metallurgically interrogated to determine the failure mode and probable cause. The revealed a multiple visual examination origin transgranular fracture surface with no visible evidence of damage near the suspected origin, as seen in Figure 2. Stereomicroscopic review of the fracture surfaces revealed apparent origins near the pressure side and suction side mid-span area of both blade remnants. The pressure side origin was ~0.018+ subsurface and the suction side origin appeared to be surface related, as seen in Figure 3. The fracture surface was predominantly transgranular, indicative of fatigue, with a small section of the fracture surface having an intergranular, dimpled appearance of the final overstress.

The microstructure of Sample 1¢ blade was examined for any anomalies and none were noted. The microstructure appeared typical for precipitation hardened AM350. Hardness readings were taken from Sample 1 and found typical of AM350 precipitation hardenable stainless steel in the heat treated condition. the average was HRC 41. Fracture Surfaces Of Both Blades Are Similar, Uncommon Crack Initiation

Oncommon Multiple Crack Initiation Sites
Both Blades Have Similar Fracture Surface Morphology

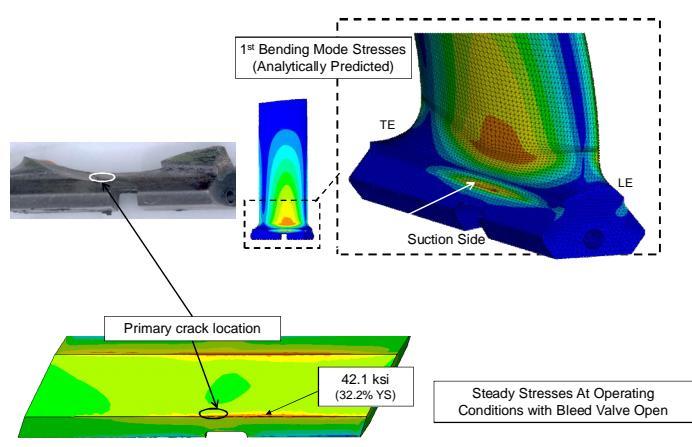
Figure 5 6th Stage Blade Structural Analysis Predictions of High Stresses in Crack Initiation Area

Initiation Site

Analytical Modeling Predicts High Bending Modal Stresses at the Crack

The 6th stage blade model was finely meshed in the airfoil root attachment area to accurately predict static stresses. Once the ANSYS model was prepared and boundary conditions applied, the analysis was run at maximum operating conditions to determine the highest static loading in the part. The model results output were posted to allow for a fillet at the cross section of the primary crack location. The stress highest in the crack initiation area and can be seen in Figure 5

Modal stress predictions show the highest stress to be at the primary crack location for the 1st bending mode. All other predicted resonant mode stress did not generate high stresses in the primary fracture location. Therefore, the analysis corroborated the metallurgical findings indicating a high deflection simple bending mode fracture. The first bending or simple cantilever bending mode on the part produces similar vibratory stress on the

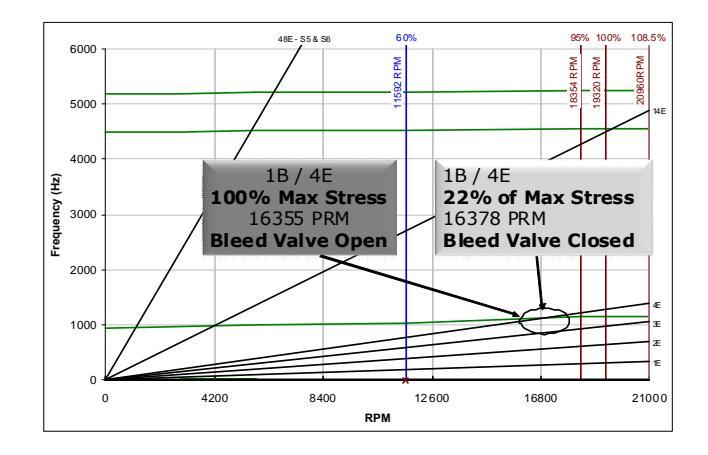
Figure 6 6th Stage Blade Campbell Diagram with Test Data

This resonant response was determined to be the first bending mode driven by a 4 per revolution (4E) driver at approximately 16300 RPM. The maximum measured vibratory stress was normalized to be considered 100% of the maximum measured stress as seen in Figures 6 and 7. Figure 6 plots the resonance on the Campbell

August 2009 Instrumented Test Identified Fracture Mode of 6th Blade

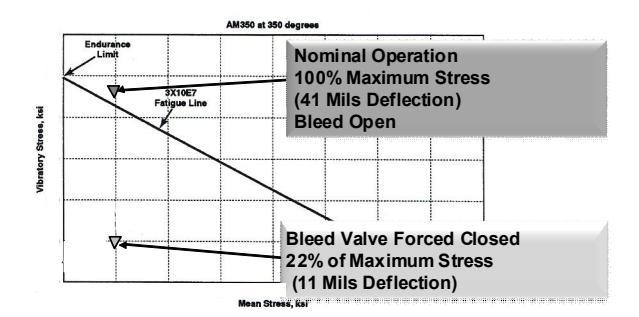
Figure 7 6th Stage Blade Goodman Diagram

Diagram. This level of vibratory stress combined with the steady stress when plotted on a Goodman Diagram above the Goodman Limit, as seen in Figure 7. The 1st bending mode also showed a 6E response, with a lower stress measuring only 22% of the maximum measured stress at 9778 RPM. The significance of this resonant crossing is that it appears there is a strong 2 per rotor revolution (2E) driver in the engine

Instrumented Test Validated 6th Blade Stresses

"Structural Analysis Used for Mean Stress at the 4E Resonance Speed

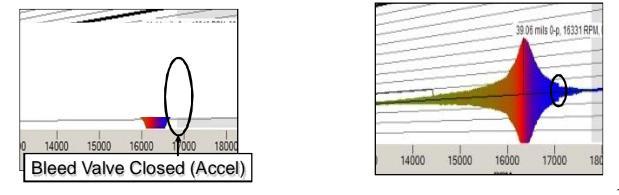
Figure 8 6th Stage Blade 1st Bending 4E Resonance Response with Bleed Open and Closed

Data reduction indicated that during a deceleration, the resonance would abnormally be excited as the engine transitioned from high speed through the speed zone of concern, as seen in Figure 8. It was determined this resonance change was related to the bleed valve opening on deceleration. It was concluded the bleed valve was the primary resonant driver. Therefore, further exploration of the resonance was conducted to determine if the resonance was driven by the exiting of bleed air from the bleed valve. This was completed by performing a normal start and forcing the bleed to be closed prior to the resonant speed zone of concern, 16128 to 16640 as illustrated in Figure 8. The 1st bending 4E resonant crossing occurred at the same speed zone, but the stresses were substantially reduced to a maximum observed stress of only 22% of the maximum stress observed with the bleed open. Plotting this stress level on the Goodman diagram shows the stress to be well within the Goodman allowable, as seen in Figures 6 through 9.

Bleed Valve Operation Is Directly Related to Stress Level

Stress Level Directly Related to Bleed Valve Operation

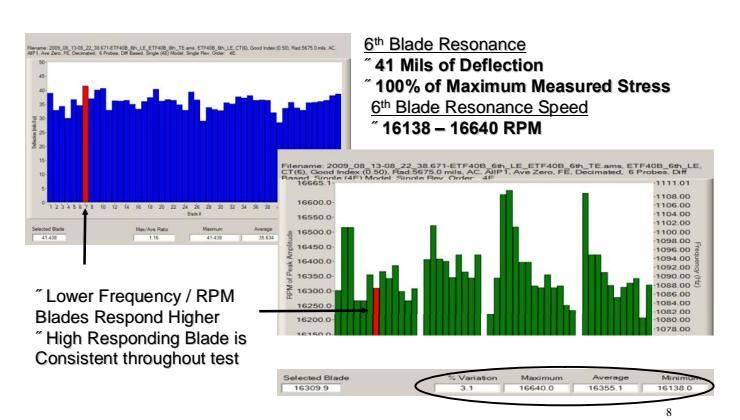
Figure 9 6th Stage 1st Bending 4E Individual Blade Deflections

Figure 9 is an additional plot of the deflection on each of the 6th stage blades in a given revolution, the deflections are considered consistent from blade to blade and within expected results, with no anomalous blade response. The speed zone of the resonance is also defined in this figure from 16128 to 16640. The variance in resonance speed is primarily driven by the geometric tolerances between each airfoil in the wheel. No high or abnormal resonances were observed at high speed/power, throughout the test.

ETF40B Strain Gage Results Show Resonance Speed Variation of 3.1%

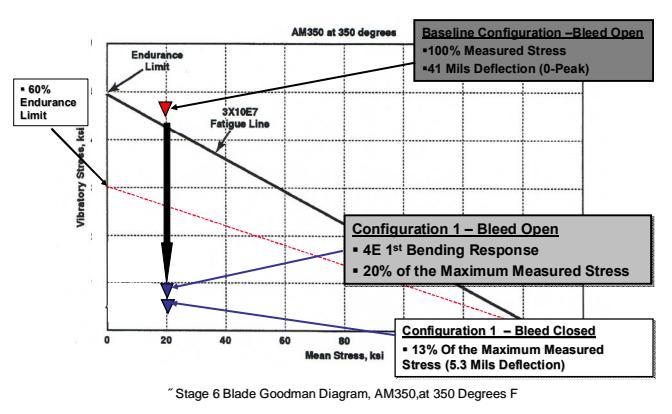
Figure 18 6th Blade Goodman Diagram Comparing the Baseline Stress to the Final Blocker Plate Configuration

Blocker Configuration Successfully Reduces Stresses to Acceptable Levels

Converting the blade tip deflections to blade stresses was completed by employing the results from the ANSYS structural analysis. A correlation was made between tip deflection and stress at the 6th blade root in the 1st bending modal results. Once the relationship was established, all the tip deflections were converted into maximum stresses at the root location. The vibratory stress was then plotted with the predicted steady stress from the ANSYS structural model on a Goodman diagram, as seen in Figure 18. The 4E and 5E modal stress was plotted on this diagram. Both the 4E and the 5E stresses are well within the 60% Goodman capability. This Goodman Diagram also shows the substantial decrease in vibratory stress with the final configuration blocker plates for the 4E response.

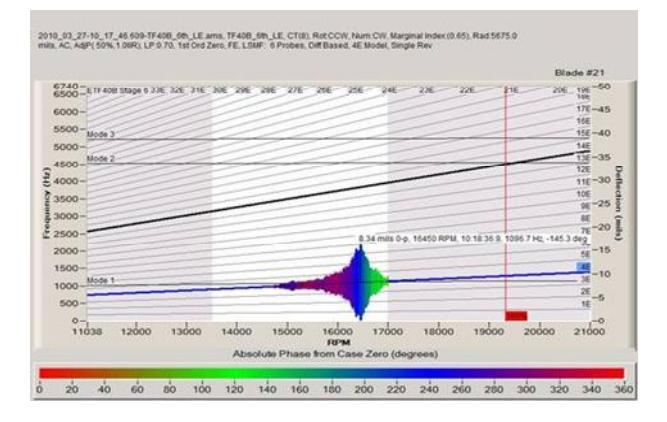
Figure 19, $\mathbf{6}^{\text{th}}$ Blade Resonance with the Final Plate Configuration . Bleed Open

4E 1st Bending Resonance Reduced to Low Levels

Characteristics of the Response Identical to Baseline Response Speed Region

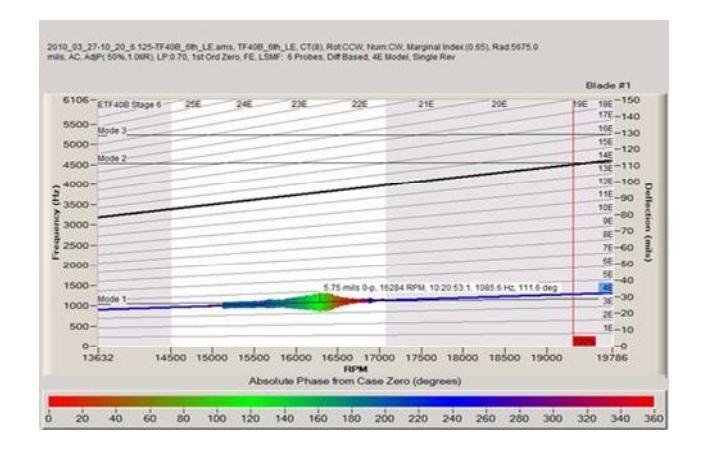
Figure 20, $\mathbf{6}^{\text{th}}$ Blade Resonance with the Final Plate Configuration . Bleed Closed

6th blade stresses with the bleed closed were acceptable as seen in Figure 28 and Figure 20. The baseline tip deflections and stresses that were taken during the August 2009 test are considered acceptable. The stresses measured during this test further reduce the levels in every blocker plate configuration.

Bleed Valve Closure Further Reduces Response To Low Levels
