### GT2011-46863

# FAILURE INVESTIGATION OF 1<sup>ST</sup> STAGE BUCKETS FROM FRAME 3002, 10 MW GAS TURBINE UNIT

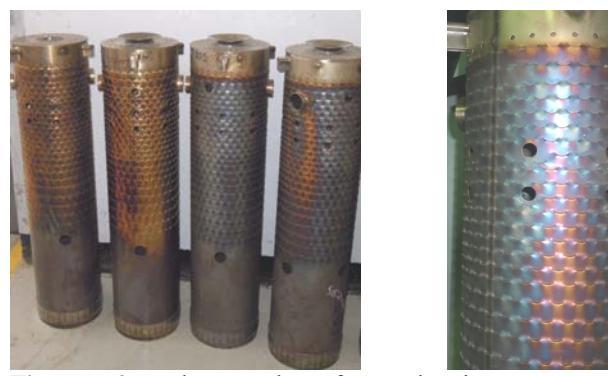
**Figure 2**: Photograph of combustion cans showing discoloration after 15 to 20 hours of service.

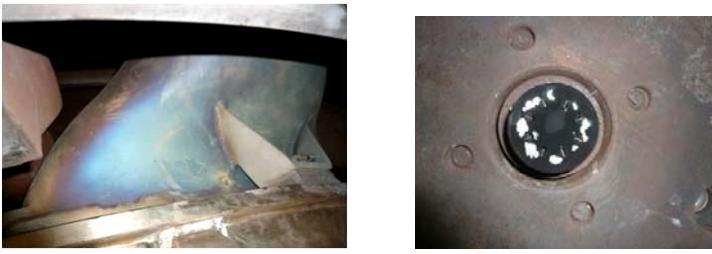
**Figure 3:** Photograph of transition piece and fuel nozzle showing discoloration.

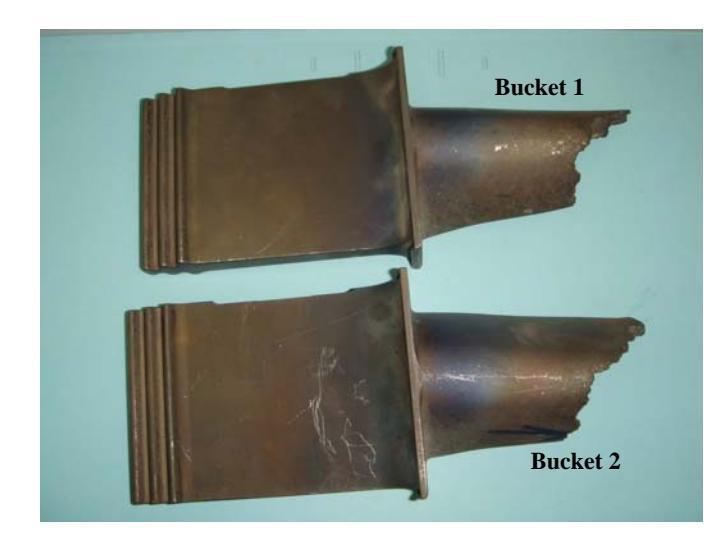
The failed buckets in the as received condition are shown in Figure 4. Fracture surface of both the buckets is similar in appearance with uneven contours and a smooth zone. The failure appears to be in the upper portion of airfoil. Buckets are hollow from inside and un-cooled. The fracture surface is oblique to blade axis. Fracture surface appears to be grayish black in color and shows signs of oxidation. Discoloration is observed near the fracture region on the bucket surfaces. This is observed on both the concave and convex surfaces. The root portion is un- affected and is sound. Root portion did not show any deformation or discoloration. The fracture surfaces are shown in Figures 5 and 6.

Un-even Contours

Figure 4: Photograph of the buckets in the as received condition.

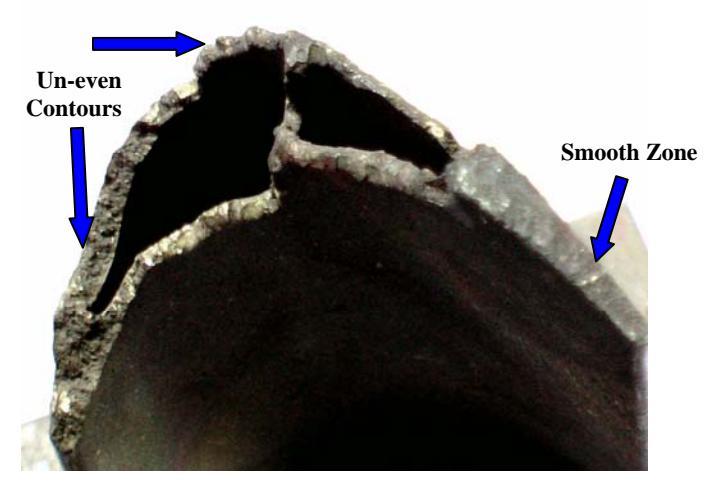
**Figure 6**: Photograph of Bucket 2 showing the fracture surface; uneven contours and smooth zone is evident.

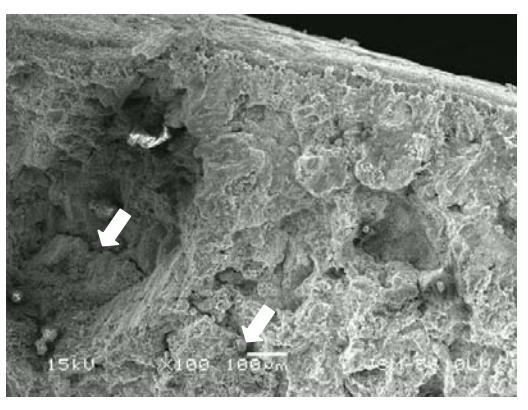
**Figure 7**: SEM photograph of fracture surface at un-even (rough zone) area showing ductile mode; secondary cracks are evident (arrows); Original Magnification – 100x

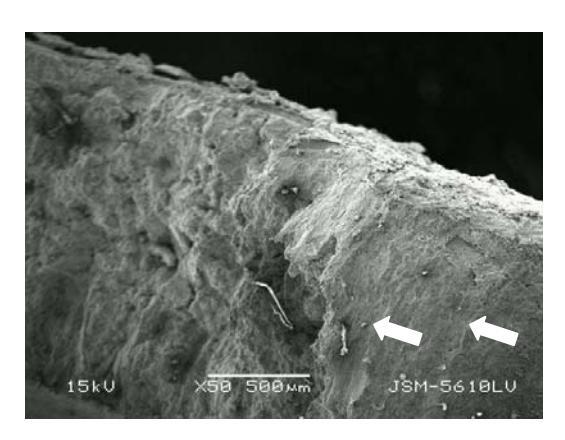
**Figure 8:** SEM photograph at fracture transition zone; showing fracture progression; mixed mode of fracture is evident; Original Magnification – 50x

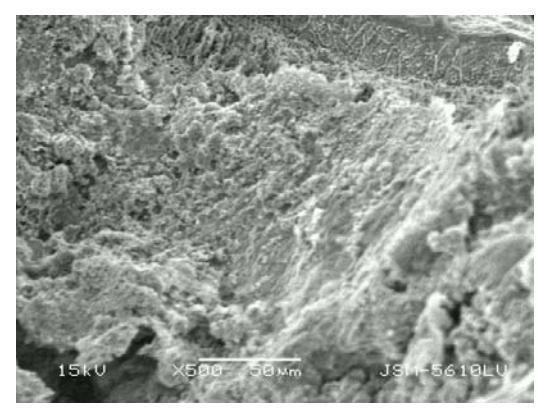
**Figure 9:** SEM photograph near to the fracture transition zone; ductile mode along with oxidized scale is observed; Original Magnification – 500x

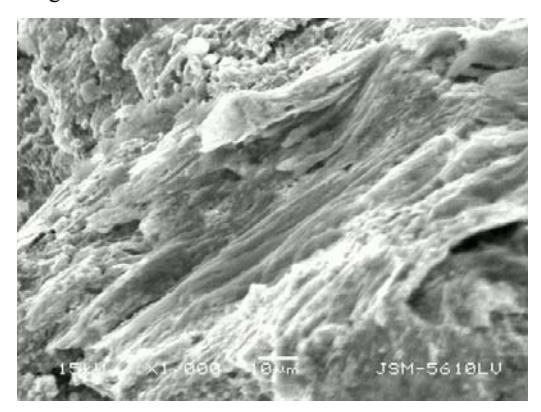
**Figure 10**: SEM photograph towards the smooth fracture zone; presence of oxidized scale is observed; Original Magnification – 1000x

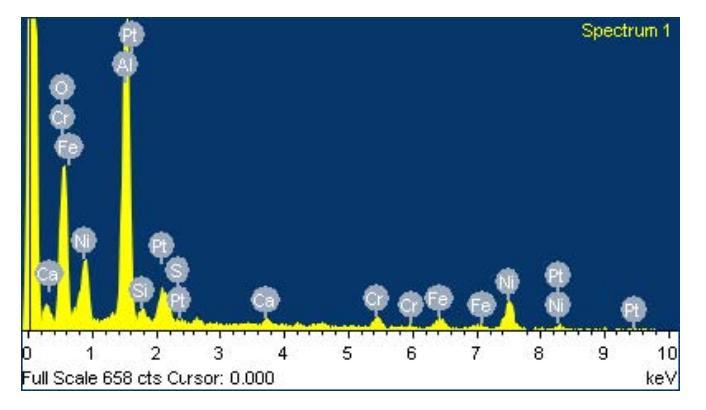
Figure 11: EDS representative spectrum performed on fracture surface towards the edge.

The analysis reveals high amount of aluminum and platinum indicating presence of platinum-aluminized coating on the bucket surface. Considerable amount of oxygen is observed. Presence of sulfur is considered as detrimental element for hot corrosion [4].

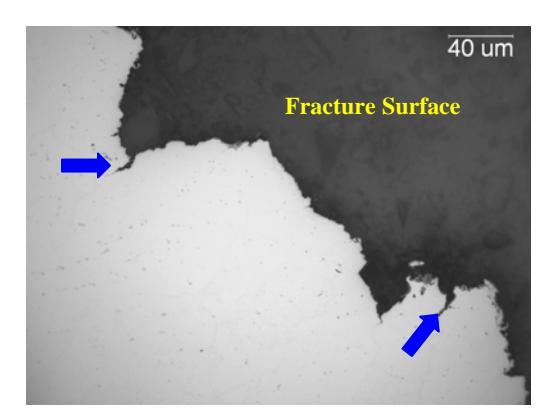
Figure 13: Photomicrograph of section near fracture; secondary cracks are evident (arrows); Un-etched.

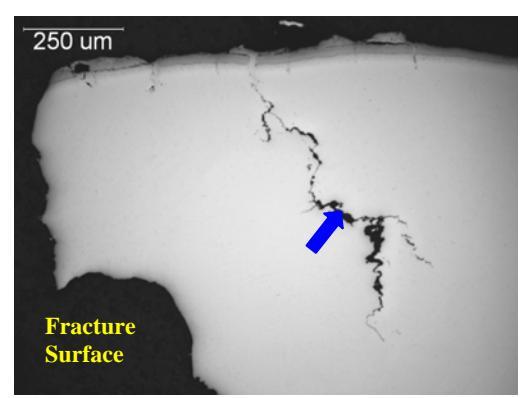
**Figure 14**: Photomicrograph of section near fracture; coating appears to be damaged and exhibits cracks; branched cracking originating from coating is evident (arrow); Un-etched.

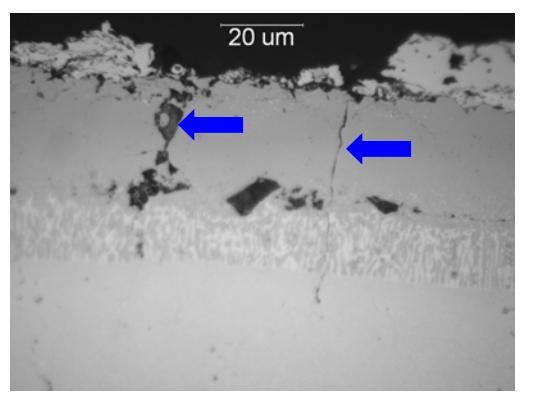
**Figure 15**: Photomicrograph of the section near the fracture surface; coating display cracks (arrows); Un-etched.

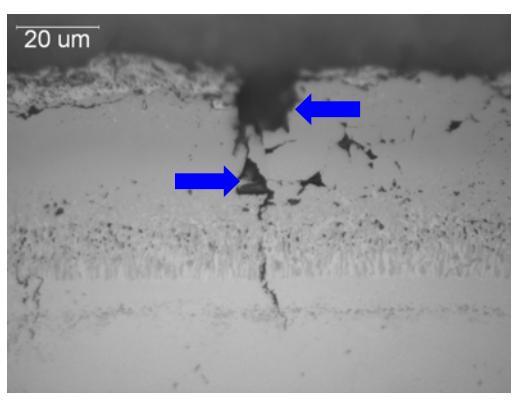
Figure 16: Photomicrograph of the section away from fracture surface; note the crack along with oxidation (arrows); Un-etched.

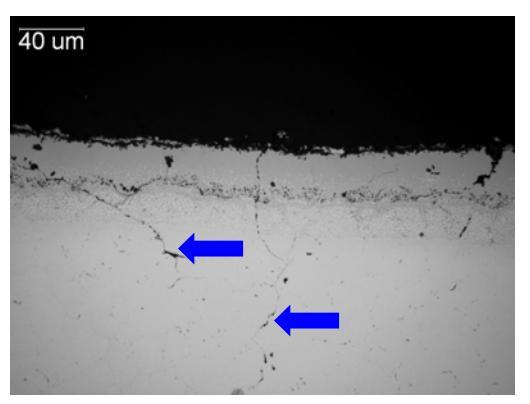
**Figure 17**: Photomicrograph of the section away from fracture surface at another location; coating displays cracks (arrows); Un-etched.

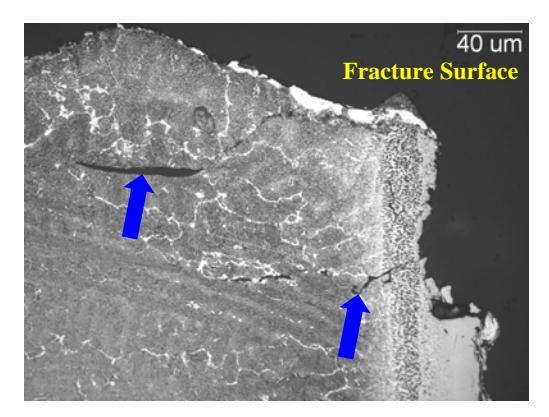
**Figure 18**: Photomicrograph of section at fracture surface; cracks initiating from coating and propagating in bucket material are evident (arrows); Etched.

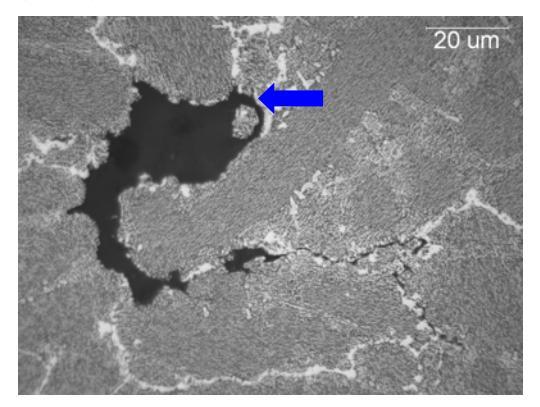
**Figure 19**: Photomicrograph of section near to fracture surface; porosity is observed (arrow); Etched.

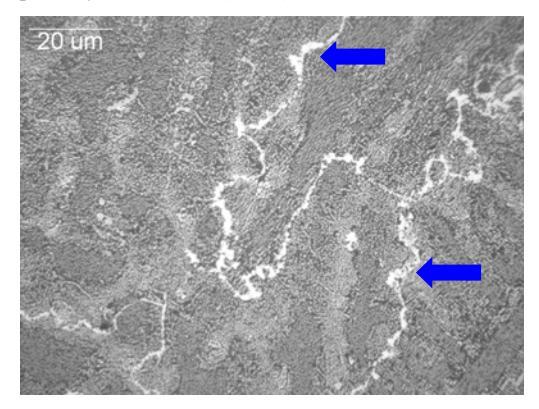
**Figure 20**: Photomicrograph of general microstructure at the fracture area; note the carbide precipitation along the grain boundary (arrows); Etched.

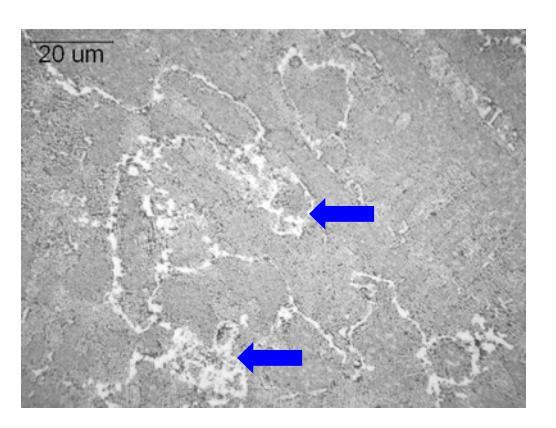
**Figure 21**: Photomicrograph of general microstructure at the midsection area of bucket (away from fracture); excessive carbide precipitation is evident along the grain boundary (arrows); Etched.

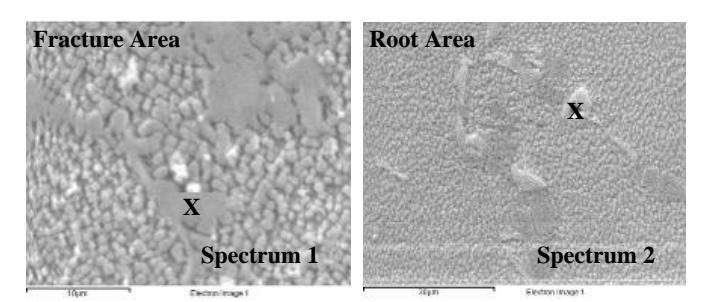
Figure 23: EDS representative spectrum performed on carbides at the fracture area and root area.

The carbides at fracture area exhibits presence of Al, Cr, Ni, and Ti. This appears to be  $M_{23}C_6$  type carbide. Carbide at the root area is rich in Ta, Ti and Nb and appears to be MC type carbide.

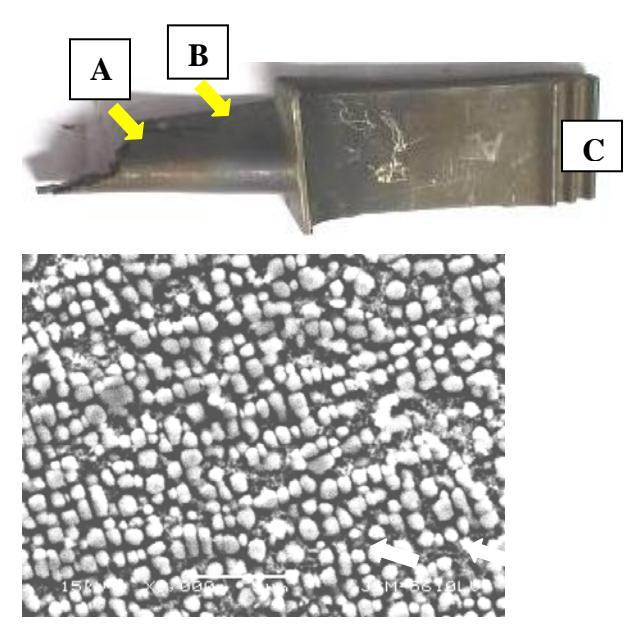
**Figure 26**: SEM photograph at Location A showing coarse gamma prime; Volume fraction 41.82%, Original Magnification – 5000x

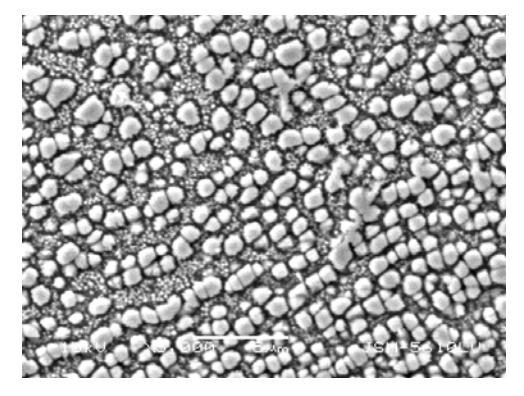
**Figure 27:** SEM photograph at Location B showing medium coarse rounded and cuboidal gamma prime; Volume fraction 37.42%, Original Magnification – 5000x

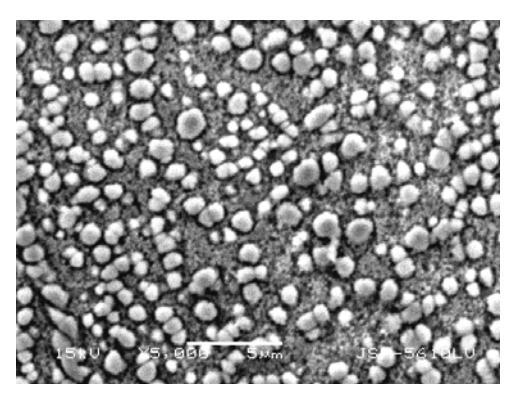
**Figure 28**: SEM photograph at Location C showing medium to fine gamma prime; Volume fraction 33.73%, Original Magnification – 5000x
