## GAS TURBINE FAILURE DUE TO WATER WASH AND EXTRACTION LINE BLOCKAGE

Abdulmajeed A. Ali

Saudi Aramco, Yanbu NGL Fractionation Department  
Industrial City, Yanbu, Saudi Arabia  
[abdulmajid.ali@aramco.com](mailto:abdulmajid.ali@aramco.com)

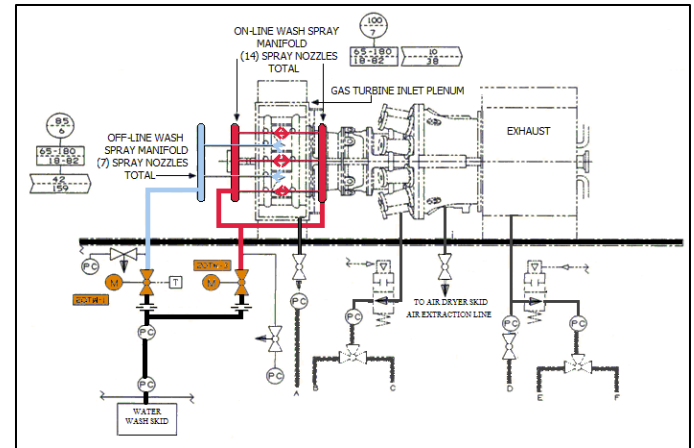
**Figure-3 Compressor Water Wash Schematic Diagram**

appropriate spray manifold for ON-LINE/OFF-LINE process. Drains from the inlet plenum, combustion area, exhaust frame, and the exhaust plenum are also provided. The schematic diagram on Figure-3 shows the on-base water wash layout.

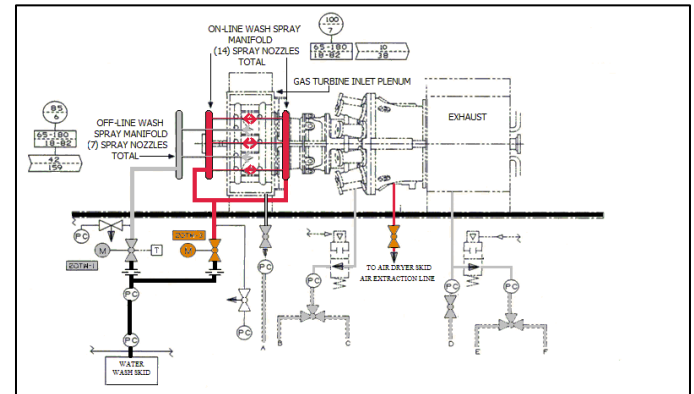
**Figure-4 Compressor On-line Water Wash Path.**

On-line water wash system consists of 14 spray nozzles on both sides of the turbine inlet plenum. The system is working in rated water pressure of 100 Psi (7 bar) at rated flow of 10 GPM (38 Ltr/min). The nozzles spray water at temperature between 65 – 180 °F (18 – 82 °C). On the other hand, the off-line water wash system consist of only 7 spray nozzles at rated pressure of 85 Psi (6 bar) and rated flow 42 GPM (159 Ltr/min) at same temperature.
