GT2011-46+* *

REPAIR PROCESS TECHNOLOGY DEVELOPMENT & EXPERIENCE OF FRAME 7FA+E, STAGE 1 TURBINE BUCKETS

**Warren Miglietti, Juan Escudero, Julio Lanza and Ian Summerside
Power System Mfg, LLC (PSM) - An Alstom Company, Jupiter, FL, USA
Zaki Zainuddin
Alstom, Baden, Switzerland**

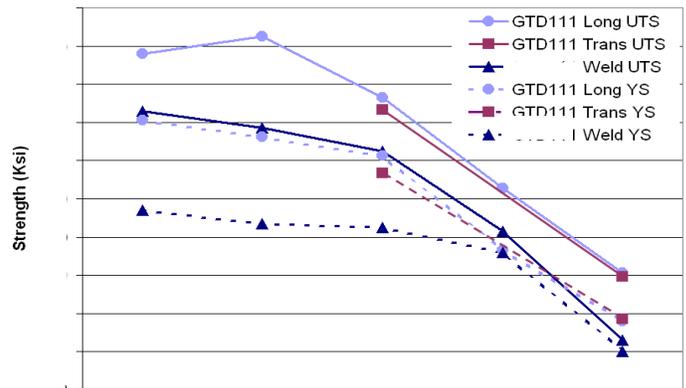
Tensile testing was performed on both DS-GTD111 specimens in the longitudinal and transverse directions, as well as specimens that were welded with the same filler metal used to repair platform cracks. Testing was performed at various temperatures from room temperature to 982°C, and the non-dimensionalized results are shown in fig 21. In summary, the UTS of the weld is equivalent to the YS of DS-GTD111 longitudinal base metal.

Figure 21 – Tensile properties of the weld repair versus the DS-GTD111 base metal (longitudinal and transverse directions)

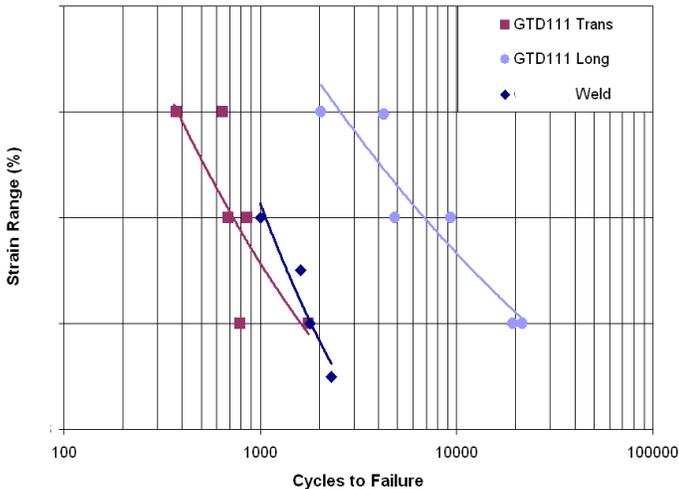
Low Cycle Fatigue (LCF) testing was also performed on both DS-GTD111 specimens in the longitudinal and transverse directions, as well as specimens welded with the same filler metal used to repair platform cracks. Testing was performed at 816°C (1500°F), and the non-dimensionalized results are shown in fig 22. In summary, the LCF life of the weld is equivalent (if not slightly better) compared to GTD111 transverse base metal.

Figure 22 – LCF properties of the weld repair versus the DS-GTD111 base metal (longitudinal and transverse directions)

Since the 1 – 4 large grains have properties equivalent to transverse properties, having the weld with equivalent properties to that of the area being weld repaired is deemed a sound repair strategy.

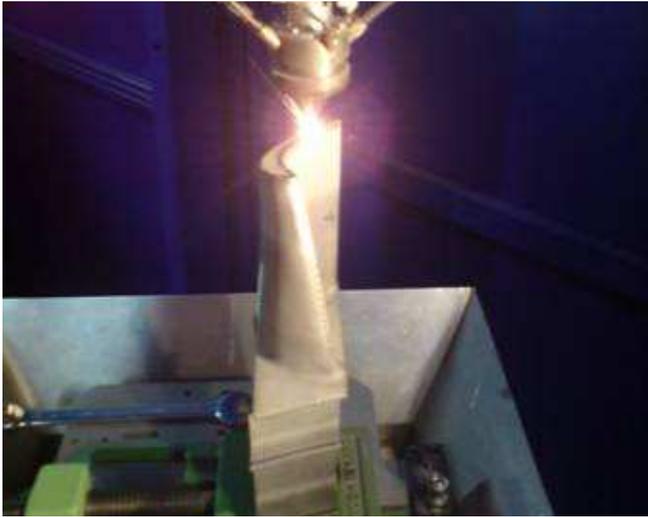
Figure 30 shows the set up of the laser welder during cladding of the squealer tip. Figures 31 and 32 show the difference between the laser clad restoration of the squealer tip versus the manual GTA weld build up. As can be seen the laser cladding restoration is near net shape, resulting in a reduction in not only cycle time but also blending time, (i.e. the squealer tip has to be contoured to that of the bucket shape). In addition the difficulties associated with weld cracking of the GTD111 superalloy while simultaneously trying to find a way of making the repair more productive than by manual GTA welding, resulted in laser cladding technology now being implemented on all production bucket repairs at this facility. The entire bucket tip weld repair, inclusive of chicklet weld attachment and the squealer tip restoration was evaluated metallurgically. The chicklet material was specially chosen and is more oxidation resistant than the GTD111 base metal. Similarly the weld filler for attaching the chicklets to the bucket as well as restoring the squealer wall was specially developed and is more oxidation resistant than the GTD111 base metal.

Figure 30 – Laser cladding during repair of the squealer tip

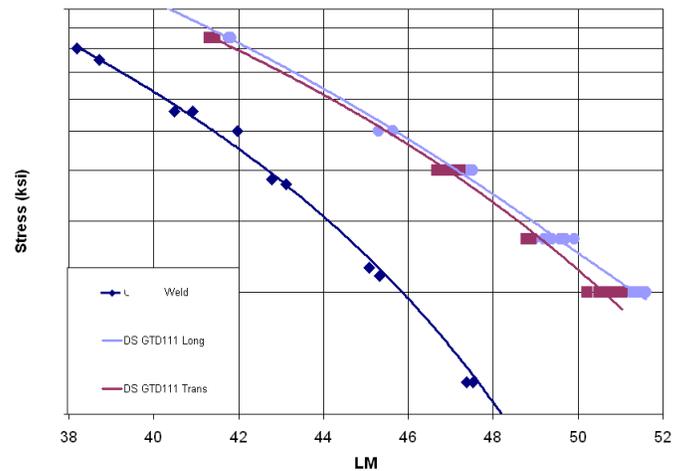
Mechanical testing was also performed to verify the choice of weld filler metal utilized for the squealer tip restoration. It should be noted that the stresses at the bucket tip are low and therefore one does not need to weld the squealer tip with GTD111 weld filler. As a result, a specially developed weld filler that was more weldable and more oxidation resistant, was utilized for the squealer tip restoration and the resultant stress rupture properties of the weld filler can be seen

in the non-dimensionalized fig 35. Obviously there is a reduction in the stress rupture properties of the weld since the weld filler does not have the same gamma prime content as that of the GTD111 base metal. In summary, the GTD111 Long and Trans Base Metal can take 1.5X to 3.5X higher stress for the same stress rupture life as the Weld. Nevertheless, the stress rupture properties exceed the design life of the bucket material at the tip.

Figure 35 – Stress rupture properties of the squealer tip weld repair versus that of DS-GTD111 base metal

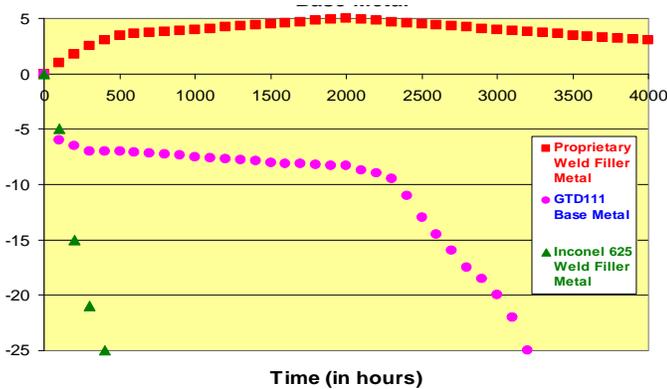
Figure 36 shows non-dimensionalized data that the oxidation resistance of the squealer tip weld filler metal is superior to that of the DS-GTD111 base metal.

Figure 36 – Weight gain/loss of the squealer tip weld repair versus that of DS-GTD111 base metal

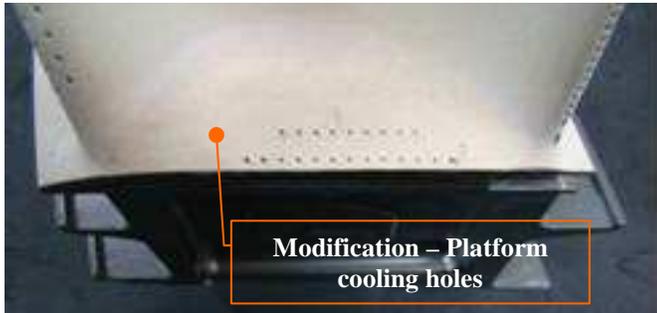
Figure 39 - Platform cooling hole upgrade

Figure 39 shows the platform cooling configuration applied to buckets that arrive for repair without any platform cooling. Figure 40 shows the VCHD TBC also applied to the tip cavity. Figure 41 shows the alternative TE undercut to that supplied by the OEM, which is applied to buckets that arrive for repair that do not have any TE undercut. Figure 42 shows the modification to the shank to allow for cooling air to reach the platform and fig 43 which is not really an upgrade, is the trailing edge cut-back (scallop) applied to buckets that arrive for repair with TE cracks as seen in fig 12.

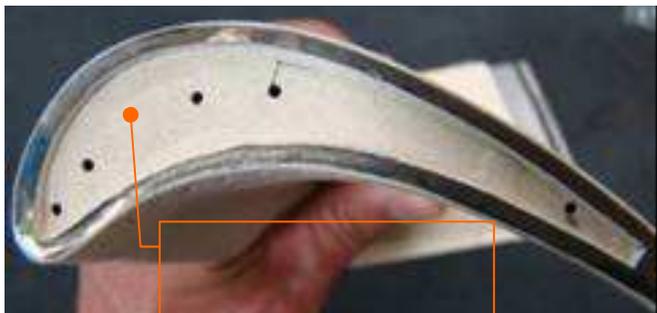
Figure 40 – Application of VCHD TBC to the bucket tip cavity

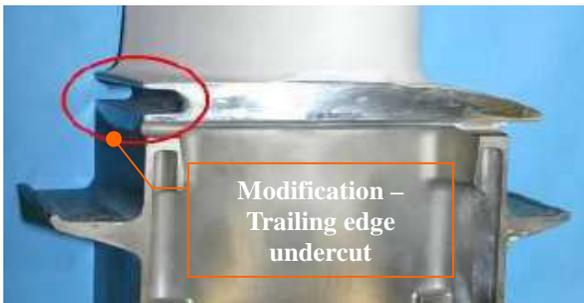
Figure 41 – Trailing edge platform undercut

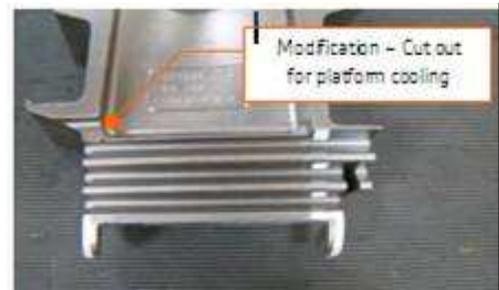
Figure 42 – Shank modification to allow cooling air to reach the platform

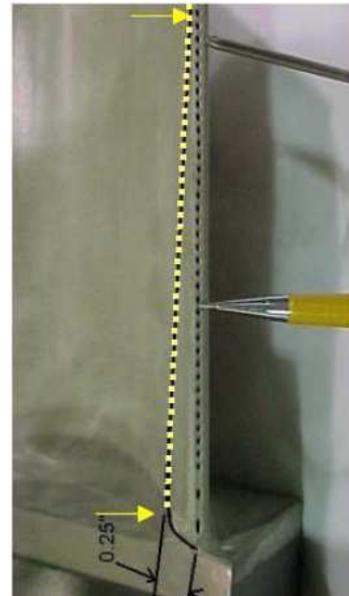
Figure 43 - TE cut-back configuration (Ref. 2)

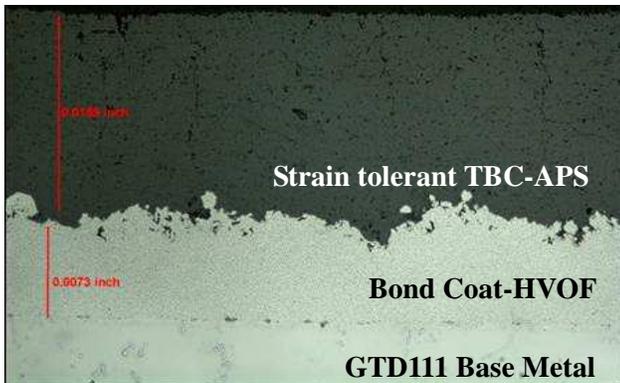
apply a VCHD strain tolerant TBC coating as seen in figure 44. Porosity-free coatings with good bonding, and oxide-free interfaces were achieved. The NiCoCrAlY+Si/Hf coating has better oxidation resistance versus GT33. For the same thickness coating at 982°C (1800°F), the former coating system had a life of 30,000 hours versus the latter coating system that only had a life of 24,000 hours based on beta phase measurements. The strain to crack test showed that both coating systems at 427°C (800°F) and 538°C (1000°F) could reach 4% strain. Figure 45 shows the general appearance of the 7FA+e stage 1 bucket fully repaired and coated.

Figure 44 – HVOF, NiCoCrAlY+Si/Hf and APS strain tolerant TBC applied to a repaired 7FA+e bucket

The OEM applies a VPS (vacuum plasma spray) MCrAlY bond coating referred to as GT33 and a dense vertically cracked (DVC) TBC. For the reconditioning process, a high velocity oxy-fuel process is used to apply a NiCoCrAlY+Si/Hf bond coat and the air plasma spray (APS) process is utilized to

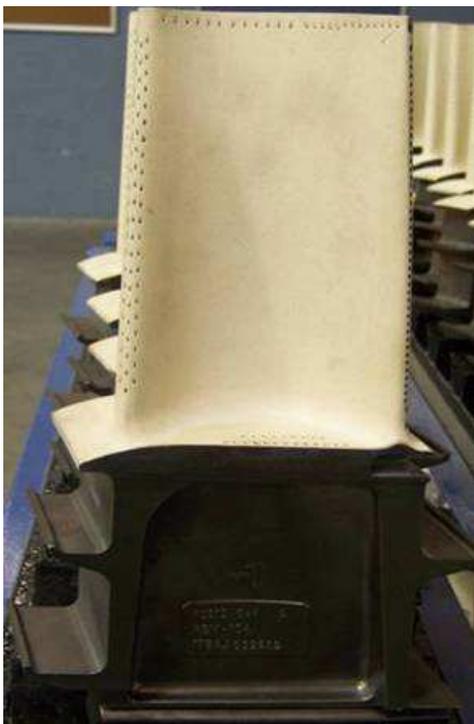
Figure 45 – Fully repaired and coated Frame 7FA+e, stage 1 bucket
