Failure Investigation of a 6th Stage Compressor Blade on a ETF40B Gas Turbine Engine

Gerrick Slogar (<u>Gerrick.Slogar@Vericor.com</u>) Vericor Power Systems Inc. 3625 Brookside Parkway Suite 500 Alpharetta, GA 30022 Gary Prus (gpp@psnet.com) Parametric Solutions Inc. 900 East Indiantown Rd. Suite 200 Jupiter, FL 33477 Benjamin Canilang (benjamin.calilang@Navy.Mil) Naval Surface Warfare Center, Carderock Division Philadelphia, PA Branch 935

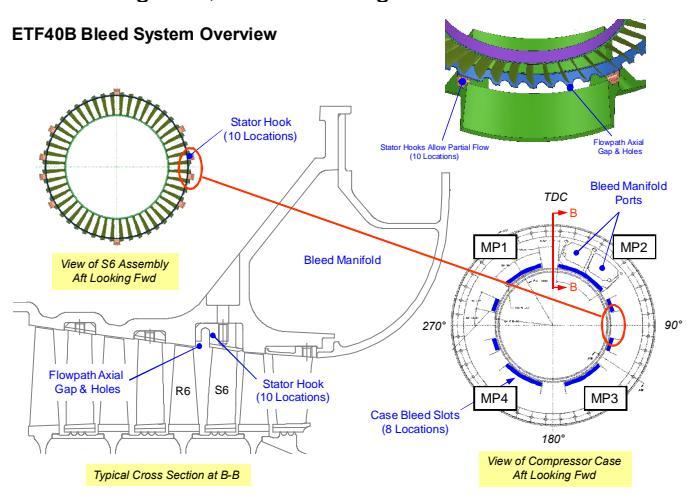
Figure 10 ETF40B 6th Stage Bleed Configuration

is seen in Figure 13. This analysis proved to be instrumental in understanding the 4E driver and ultimately reducing the 6th blade 4E 1st bending resonant stresses. The Fourier analysis evaluated the blockages in the bleed port, including the 6th vane attachment hook and half circles, bleed port size and location. Experimental engine data obtained from a previous test was not adequate to separate the effects of the 6th vane retention hook and the half circle cut outs in-between each airfoil; therefore the analysis included the effects of these features, as seen in Figure 10.

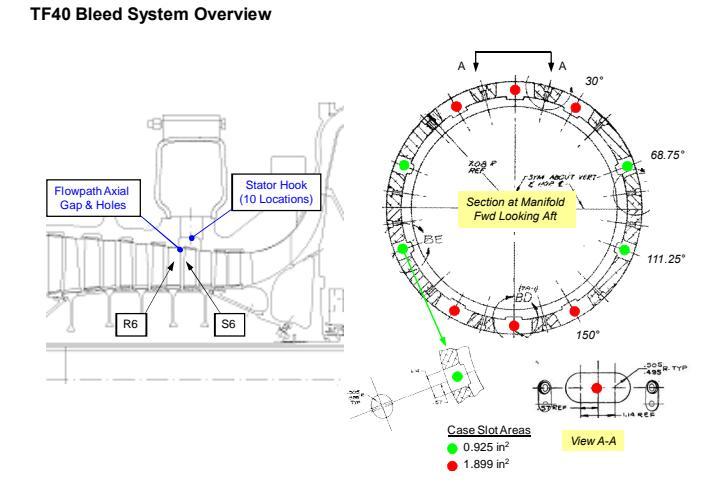
Figure 11 TF40 Bleed Configuration

Review of previous test data provided insight into the root cause of the 4E / 1st bending response driver. Historical 6th blade strain gage data taken during TF40 testing in the early 1970c showed a significant change of ^t bending 4E response with the bleed open as the 1^s compared to operation with the bleed valve closed. The data from the TF40 and ETF40B testing showed there was an impact to 6th blade stresses from the bleed system and the difference between the two enginecs bleed systems could account for the higher ETF40B stress levels. The ETF40B and TF40 bleed configurations can be seen in Figures 10 and 11. Figure 12 is a graphical depiction of the port size and quantity differences between the TF40B and the ETF40B. It can be seen that there are fewer and larger ports on the ETF40B. A comparison of the flow area for each of the bleed system components concluded the area at the flow path to be the same but elsewhere in the system showed significant differences in flow area and configuration. this can be seen in Figure 12. The flow area of the flow path consists of half circle cut outs forward edge between each vane and a gap between the forward edge of the stator and the compressor case. The 6th stator is attached to the compressor case by retention hooks, Figure 10, on the stator. The retention hooks are not in the same location for the TF40 and the ETF40B due to the configuration of the bleed slots. The hooks tend to separate the bleed flow into sections through each bleed slot.

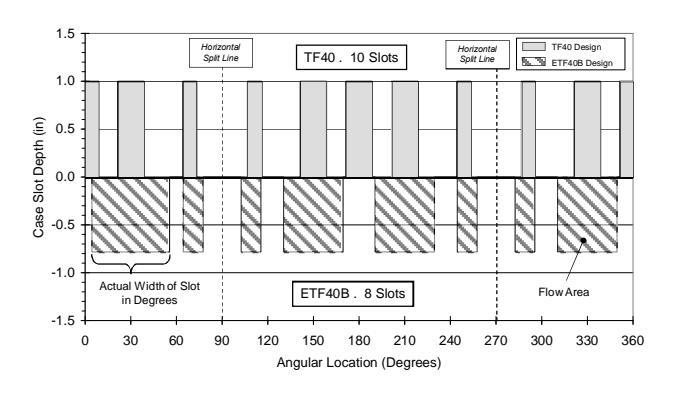
Figure 12 Compressor Case Bleed Port Comparisons between the ETF40B and the TF40

TF40 / ETF40B Case Bleed Slot Flow Area Comparison

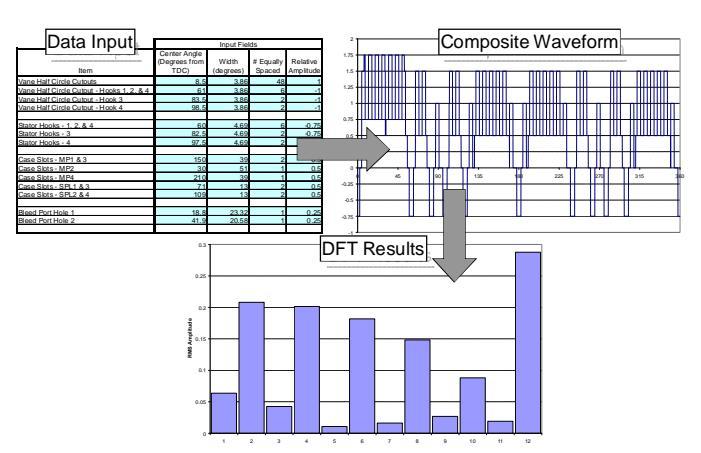
Figure 13 Fourier Analysis Model

Data Input used to Construct Waveforms and Generate Predicted Fourier Results

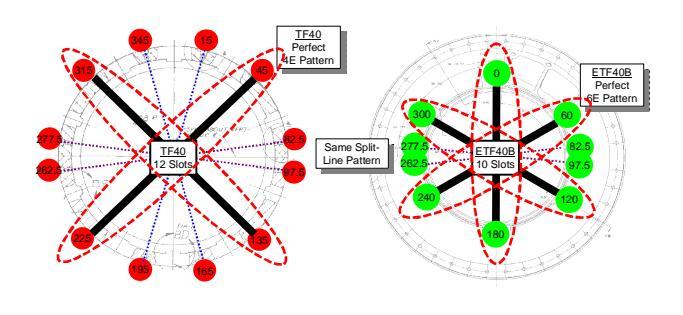
Figure 14 ETF40B and TF40 Configuration

" Driver Pattern Comparison Between the TF40 and the ETF40B shows a Significant Pattern

- Differenced in the Bleed Port Design TF40 Pattern Generates a Two Out of Phase 4E Patterns that Cancel Each other Out
- The ETF40B Generates a 6E Pattern

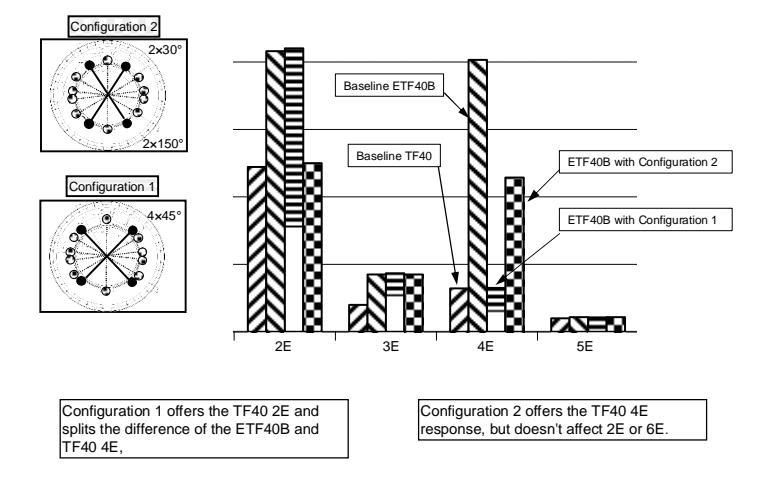
Figure 15 Fourier Analysis Results

The initial results from the Fourier analysis of the TF40 compared to the ETF40B showed that the 4E driver was significantly stronger in the ETF40B as compared to the TF40. as seen in Figure 15. The results were interrogated to understand the 4E driving function in the ETF40B, or the lack of the 4E driver in the TF40. It was discovered that the TF40 bleed port design generated two 4E signals that are out of phase with each other, thus the two signals cancel each other resulting in lower overall amplitude of the 4E driver in the TF40, as seen in Figure 14. The ETF40B configuration created a 4E and a 6E pattern with the 4E signal prediction being larger than the 6E, these results can be seen in Figure 14. Additionally, the ETF40B 4E and 6E configuration could potentially amplify each other as compared to the signal cancelation that occurs in the TF40.

ETF40B Fourier System Response Analysis
