COUPLING FAILURE FOR TORSIONAL FATIGUE: A MULTI-DISCIPLINARY ROOT CAUSE ANALYSIS APPROACH

GE Oil&Gas, Florence, Italy, I-50127,
valerio.rossi@ge.com

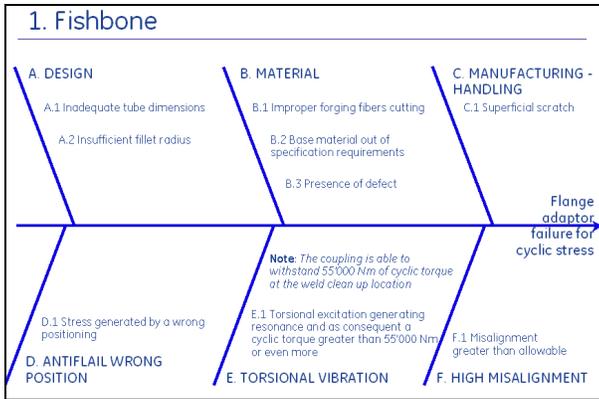
Figure 5: RCA FISHBONE

shows the fishbone associated to the RCA process: the first three aspects are relevant to coupling performance lower than expected; whereas the last ones are relevant to operation conditions more severe than expected.

Although all the potential causes listed in the fishbone were investigated during the RCA process, only a part of them will be reported in this paper that will focus on the causes that resulted determinant for the failure.

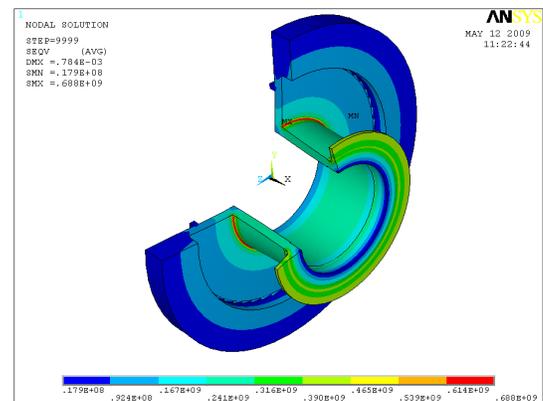
Figure 9: OVERALL VON MISES MEAN STRESS CONTOUR PLOT

The coupling capability was verified in the failed point using a FE analysis and a fatigue assessment by Goodman diagram. All the load cases were singularly run and the mean stresses and the cyclic stresses were put all together in 2 separate load case combinations. The FEM results are shown at , , and .

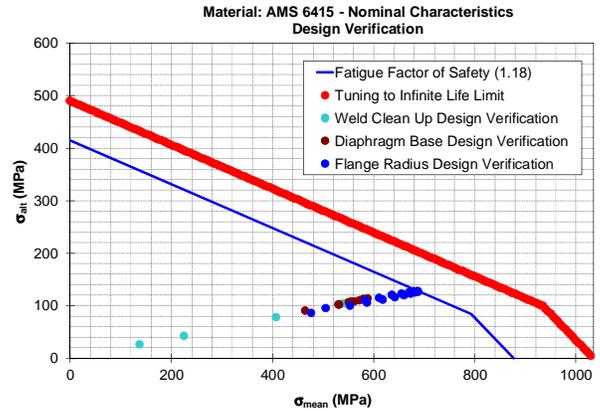
Figure 13: DESIGN VERIFICATION GOODMAN DIAGRAM

The resulting Goodman diagram is shown at the figure. The red line is the modified Goodman infinite life (obtained from Wöhler tests with high cycles fatigue resistance $>10^7$ cycles) and the blue line is the life safety factor (1.18) obtained during design verification. The knee at the lower right end of the figure is a characteristic correction used to take in account the yield strength of the material.

The conclusion is that the peak stress in the flange adapter with all applied loads has a 1.18 service factor on the infinite life limit (red line). Therefore as designed the coupling stress results are suitable for the application. It must be considered that the real operating conditions are much less severe than what considered in terms of coupling capabilities. The mean torque is not higher than 198000 Nm and the bending and axial stresses should be normally negligible. The cyclic torque is in general much lower than 55000 Nm. With this being said, there must be an additional stress riser or operational impact that then occurs for the failure to occur.

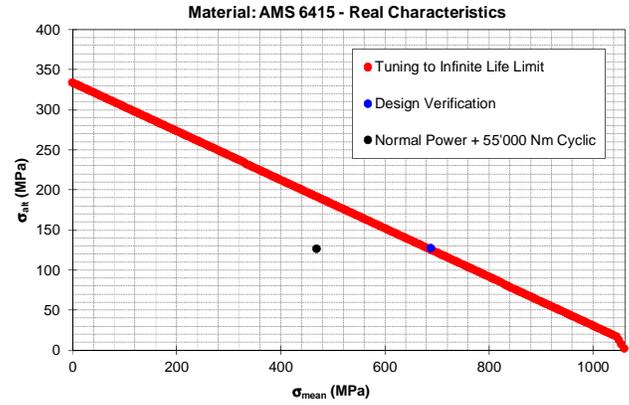
Figure 15: GOODMAN DIAGRAM WITH REDUCED MATERIAL CHARACTERISTICS

A fatigue testing campaign was performed to estimate the infinite life fatigue limit of the material in the failed location. The tests were performed on an identical piece taken from another coupling adapter machined using the same material and the same forging and manufacturing processes. Samples have been taken from the same position where the failure occurred in the investigated component. Fatigue testing was conducted at room temperature in load control on servo-hydraulic equipment employing a 30 Hz sinusoidal waveform and an R ratio of -1. The results showed a 32% strength reduction due to the manufacturing process. An as-measured Goodman diagram based on the reduced material characteristics has been reported in in order to check the reliability of the component under design and normal operating conditions. In the graph, the blue point is characteristic of the design verification (worst condition); the black point is, instead, the expected stress working point of the coupling, obtained considering the normal cyclic torque and the mean torque during normal power generation (about 75 MW).

As can be seen, rated mean torque (290578 Nm, design verification) and normal mean torque (198000 Nm, normal power condition) combined with the guaranteed cyclic torque (55000 Nm) are not sufficient to drive the coupling to a failure.

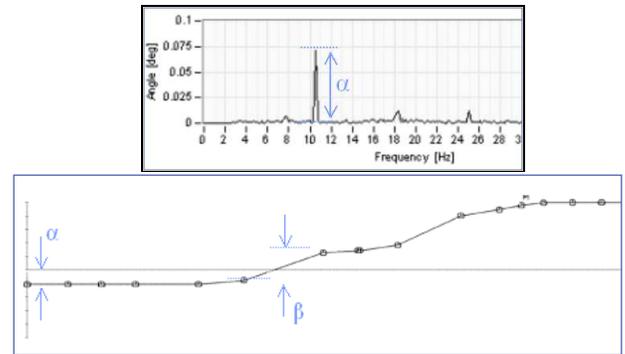
Figure 18: STRESS EVALUATED STARTING FROM MODE SHAPE

The hypothesis of high TV as a root cause was then reinforced by the test measurements at site, as alternating torque values up to 112 kNm 0-pk were detected.
